Sun StorEdge™ 6320 System 1.0 Release Notes

Part No. 816-7880-11
May 2003, Revision A

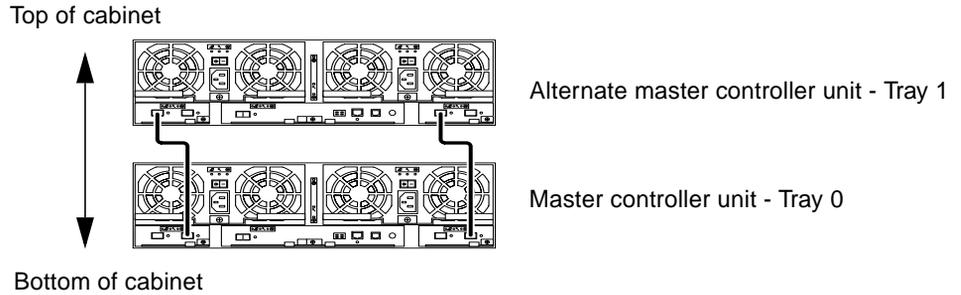
Figure 1 illustrates the HA configurations and the corresponding tray number in the Sun StorEdge Configuration Service software.

FIGURE 1 2x2 HA Configuration and Corresponding Tray Numbers

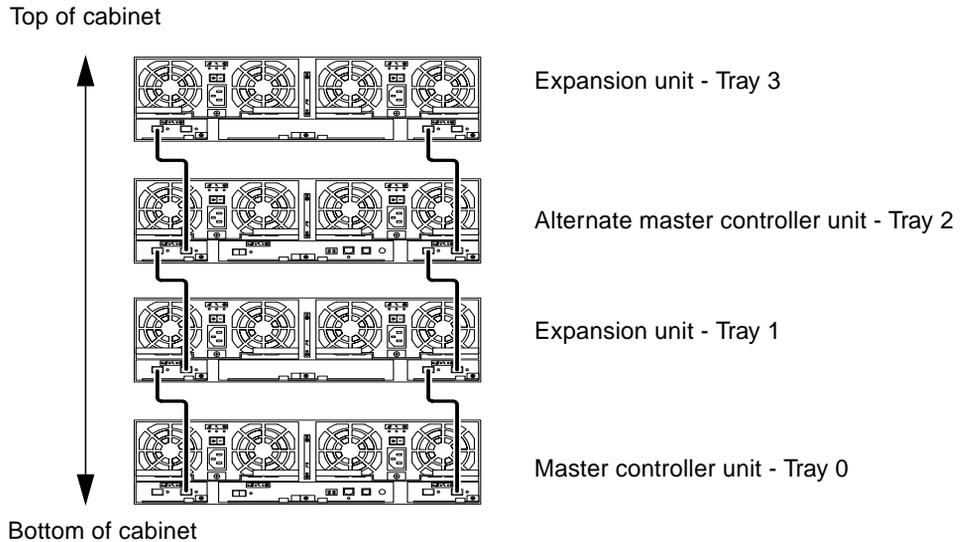
FIGURE 2 illustrates a Sun StorEdge 6020 array 2x4 HA Configuration and Corresponding Tray Numbers.

FIGURE 2 2x4 HA Configuration and Corresponding Tray Numbers

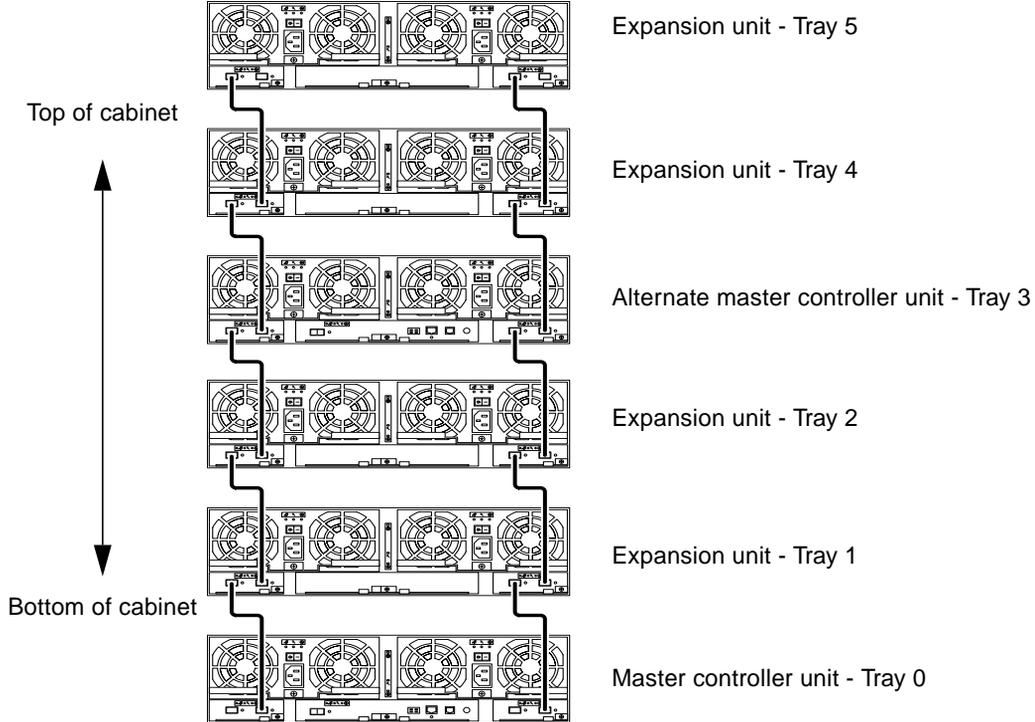
FIGURE 3 illustrates a Sun StorEdge 6020 array 2x6 HA Configuration and Corresponding Tray Numbers.

FIGURE 3 2x6 HA Configuration and Corresponding Tray Numbers
