Sun StorEdge™ 6120 Array Release Notes

Version 3.0.5 Firmware and Sun StorEdge
Configuration Service Software Version 2.1

Part No. 817-0201-10
May 2003, Revision A

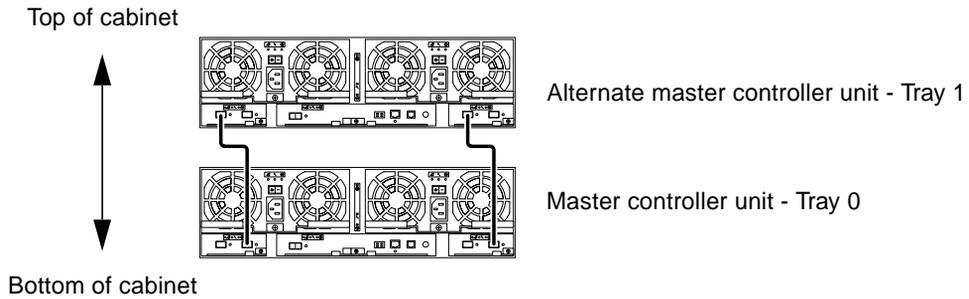
FIGURE 1 2x2 HA Configuration and Corresponding Tray Numbers

Figure 1 illustrates the HA configurations and the corresponding tray number in the Sun StorEdge Configuration Service software.

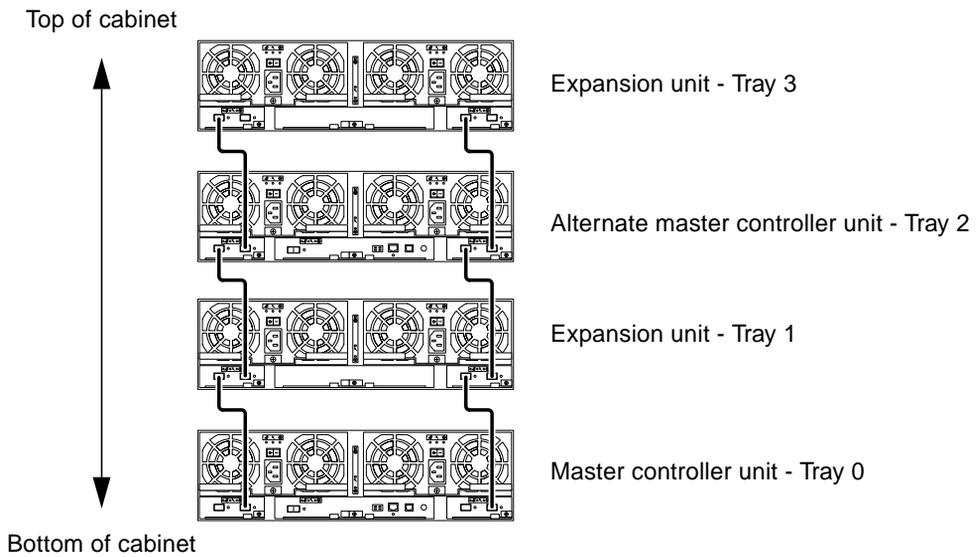
FIGURE 2 2x4 HA Configuration and Corresponding Tray Numbers

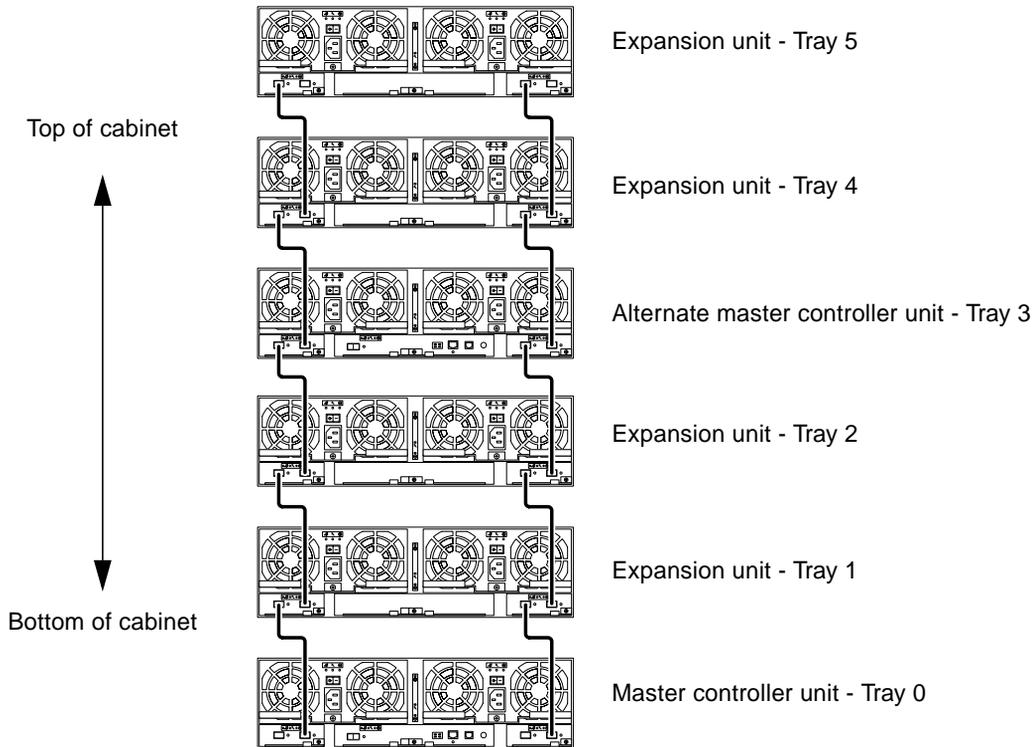
FIGURE 3 2x6 HA Configuration and Corresponding Tray Numbers

Note – When using the management software to change the array configuration, make sure that the master controller unit is identified as Tray 0 when you begin. If there has been a failover operation to the alternate master controller unit, the alternate master controller unit assumes the master controller unit status. When this happens, the master controller unit tray number updates to the tray number of the alternate master controller unit. To change back to the original configuration and tray numbering, you must reset the array controller.
