HP LTO Ultrium tape drives technical reference manual

Volume 1: hardware integration

LTO5 drives

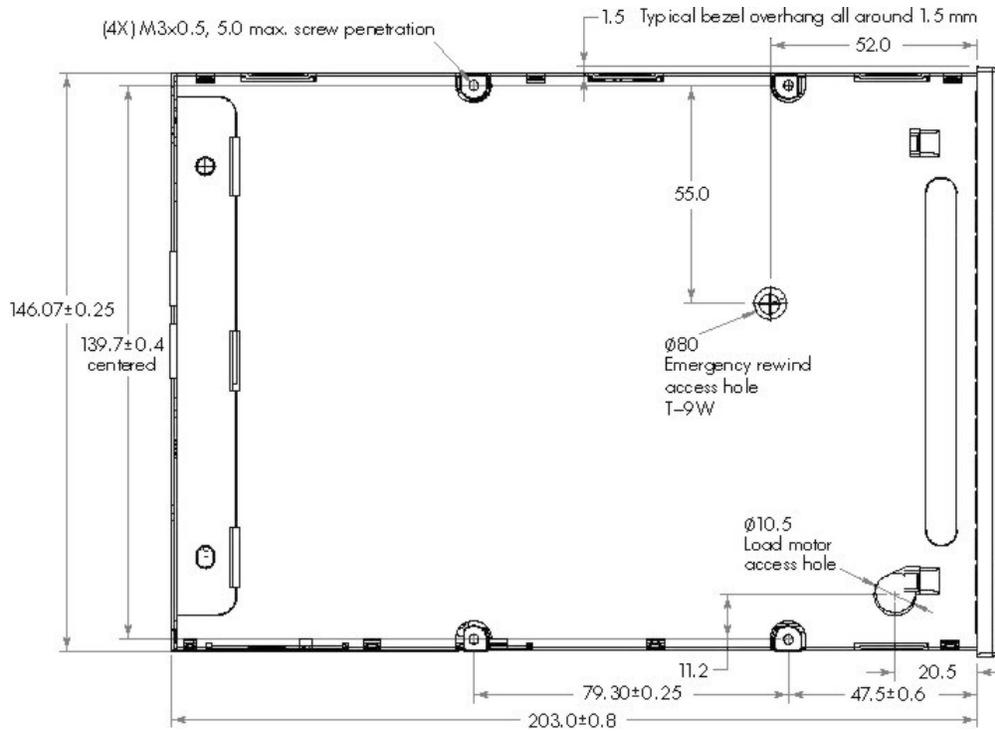
Full-height drives: bottom panel

Mounting Points	Maximum Screw Penetration
Side	5 mm
Bottom	5 mm

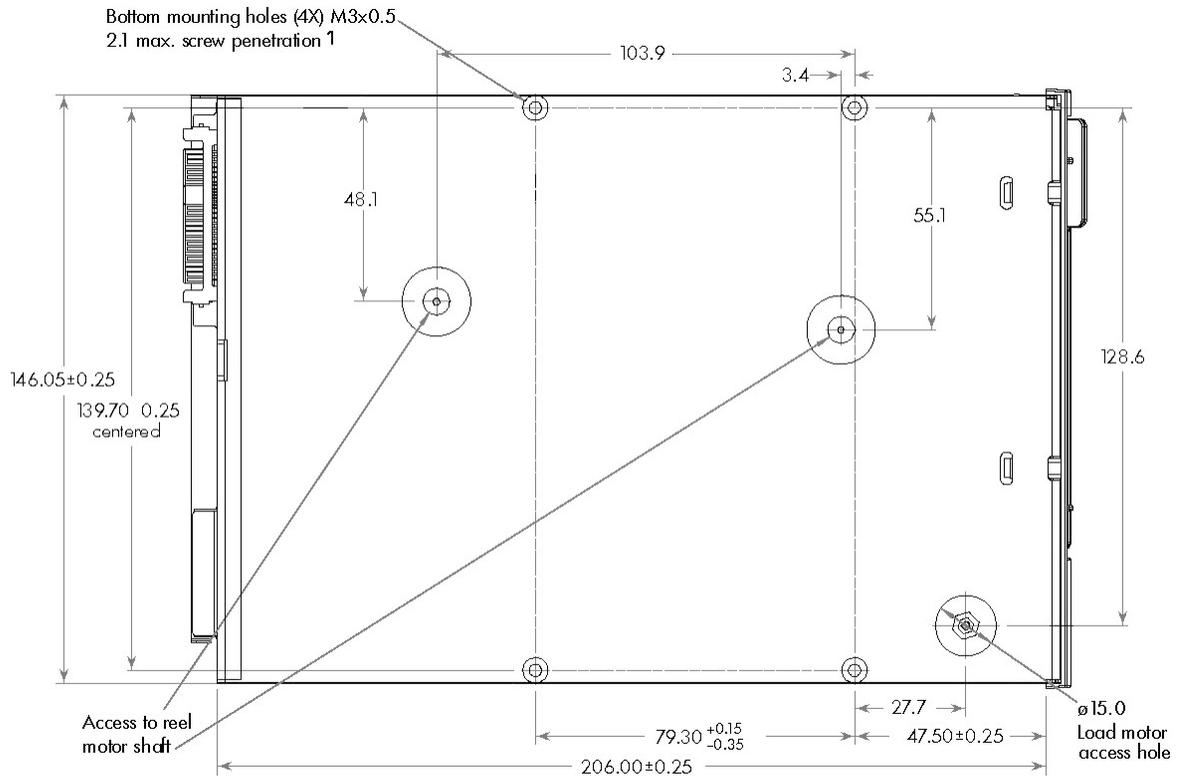
Half-height drives: bottom panel

Mounting Points	Maximum Screw Penetration
Side	3 mm
Bottom	2.1 mm

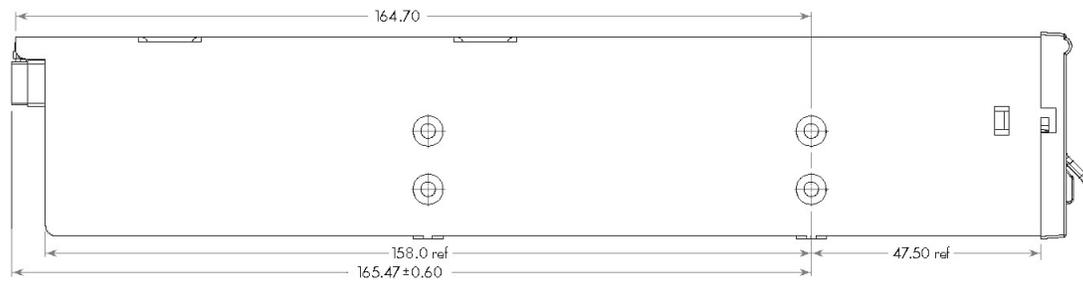
FC drives:

Half-height drives: side panel

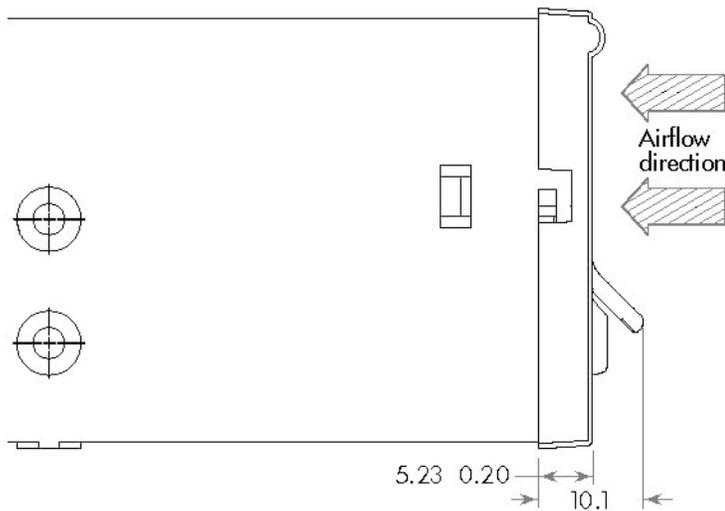
Air-flow must be from front to back. The required flow is 5 cfm for ambient air temperatures fluctuating in the range 10°C–40°C.

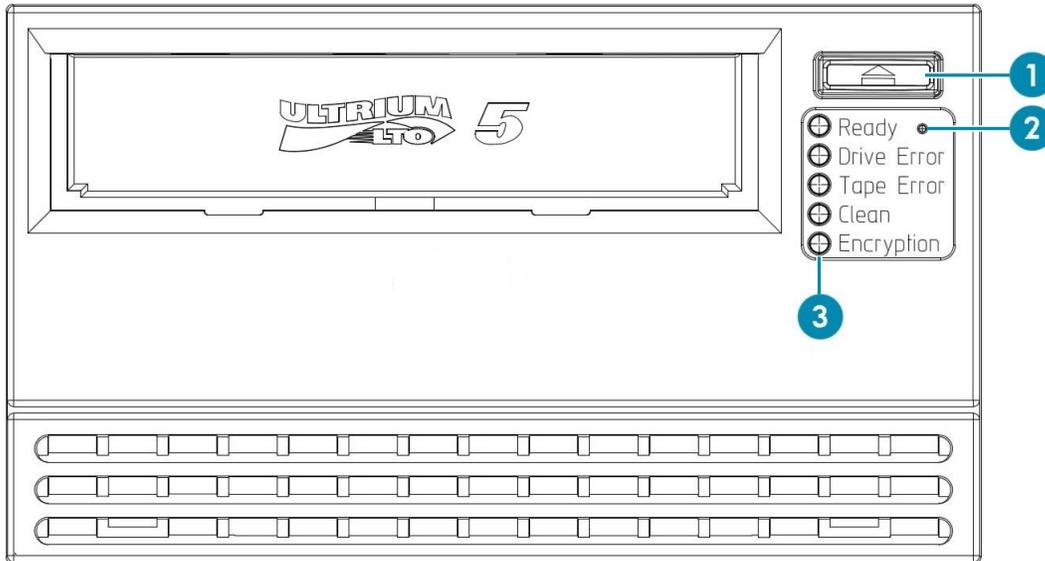
Full-height drives

1. Eject button

2. Access hole for emergency reset switch

Only full-height drives have a reset switch.

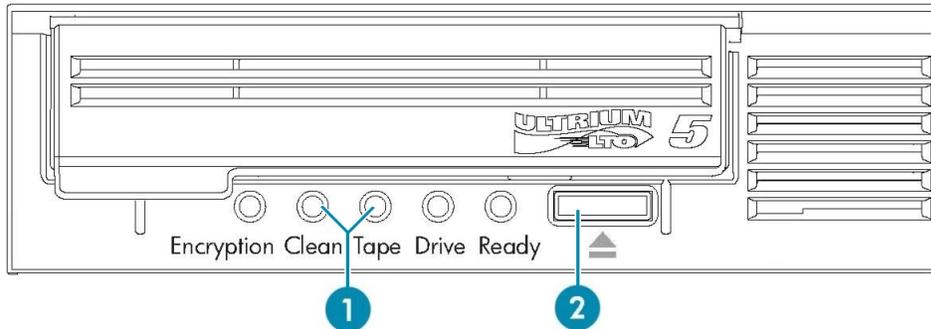
Half-height drives

1. LEDs

2. Eject button

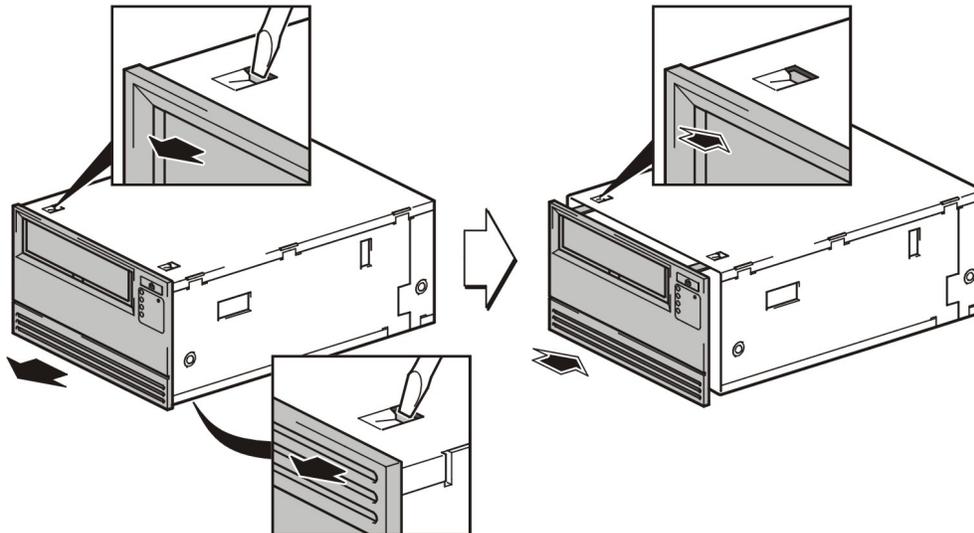
Replacing the front panel on an full-height LTO Ultrium drive

1. Use the screwdriver to release the tabs at the top of the chassis and underneath.
2. Pull the front panel towards you and away from the drive.

To replace the panel, line up the four tabs with the chassis and push the panel firmly into place. There will be a slight click when the lugs are located in the chassis.

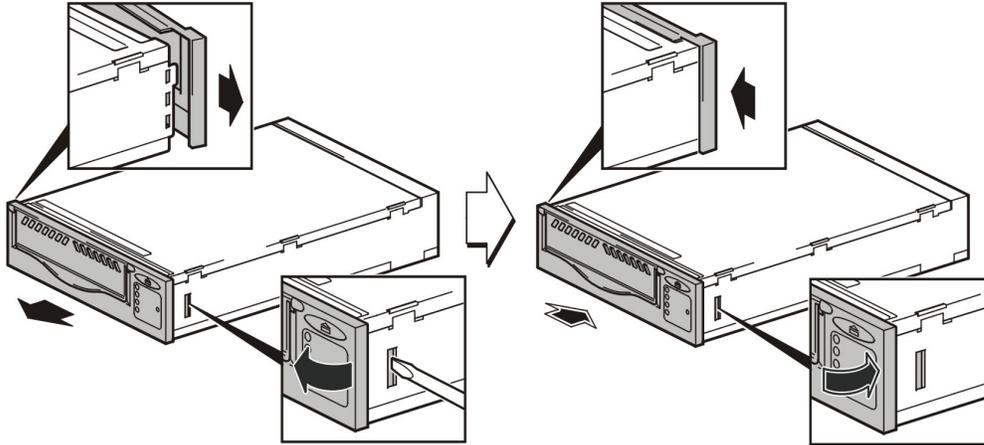
Replacing the front panel on a half-height LTO Ultrium drive

1. Use the screwdriver to release the tab on the right side of the chassis (next to the red warranty sticker).
2. Swing the front panel out slowly, pulling it gently to the left, so that the lugs release on the left side of the chassis.

3. To replace the panel, line up the lugs on the left side of the chassis and swing the panel firmly into place.

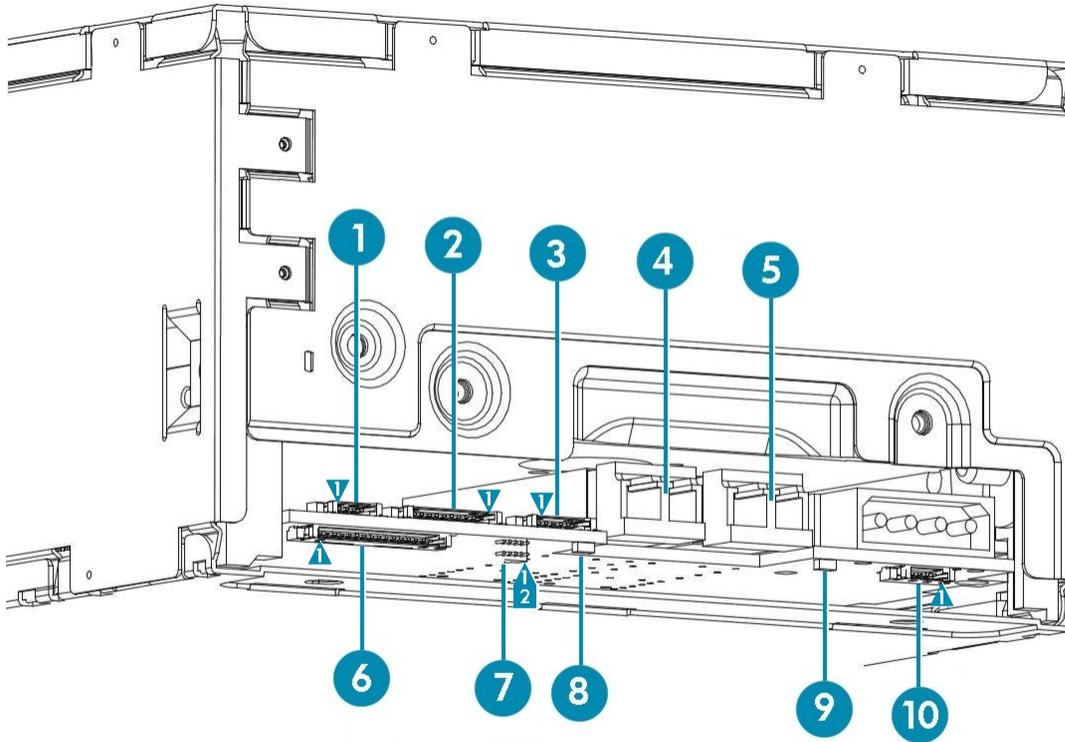
Figure 1 Rear panel components for a full-height Fibre Channel drive

| 9. Port B LED | 10. Diagnostic serial port (4-pin) |

▼ Position of pin 1 (which may be different from previous generation drives)

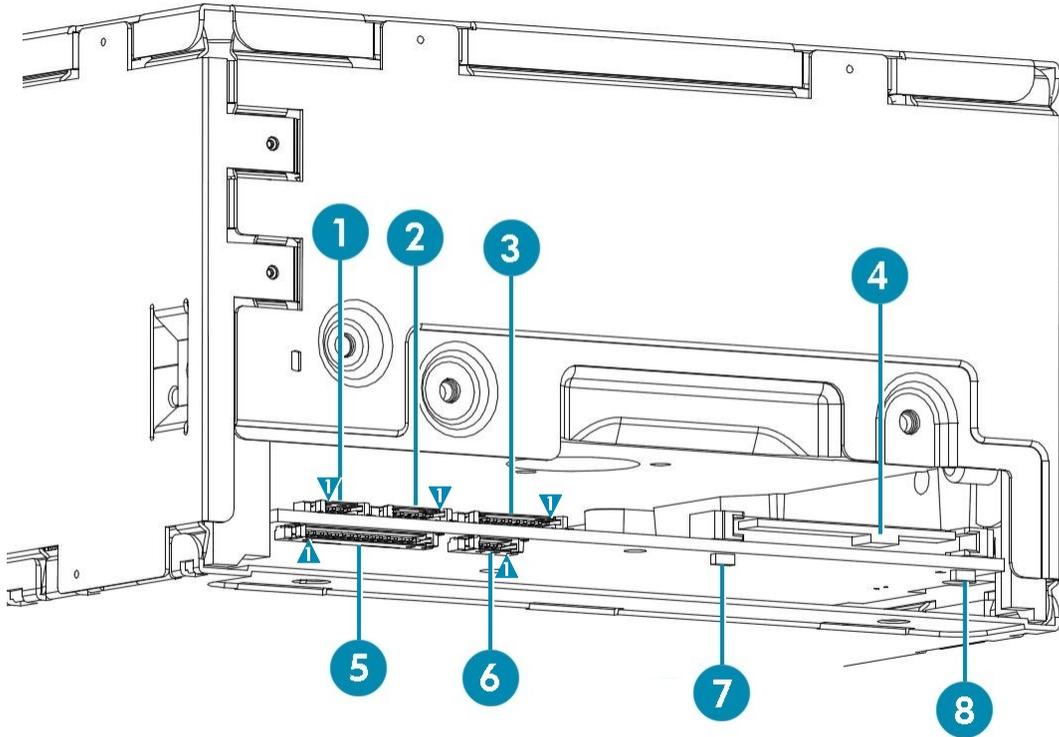
Figure 2 Rear panel components for a full-height SAS drive

▼ Position of pin 1 (which may be different from previous generation drives)

For the location of the rear panel SAS connector, see [Figure 2](#) on page 33.

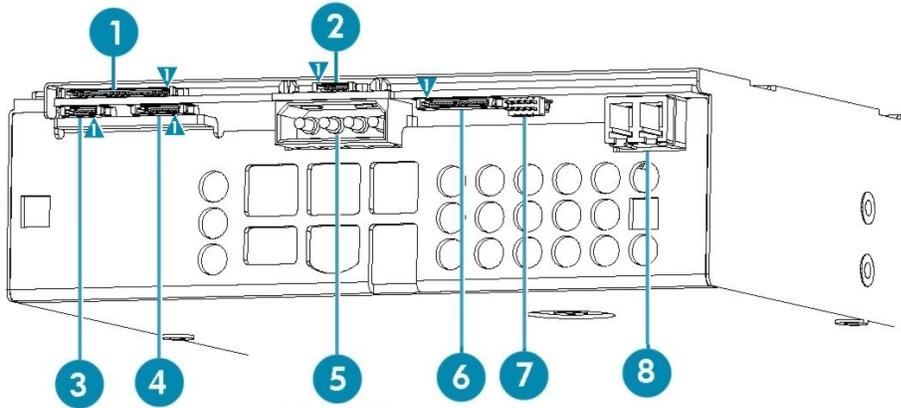
Figure 3 Rear panel components for a half-height FC drive

| 7. AL_PA jumpers (may not be loaded) | 8. FC optical connector |

▼ Position of pin 1 (which may be different from previous generation drives)

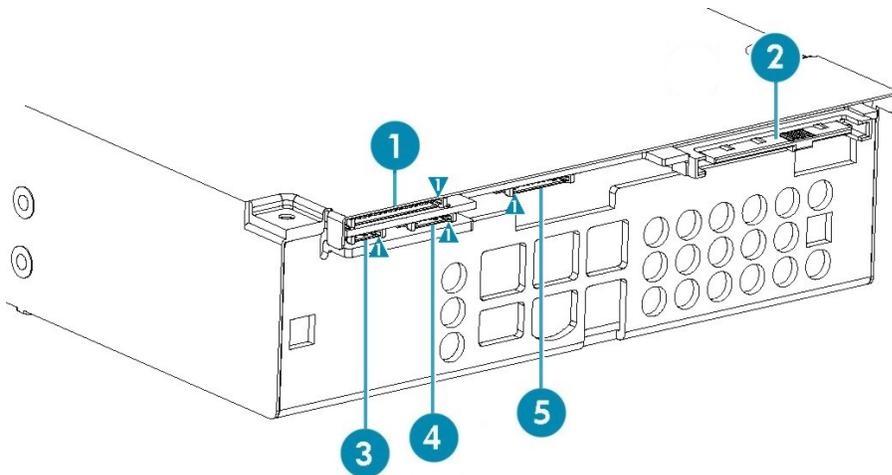
Figure 4 Rear panel components for a half-height SAS drive

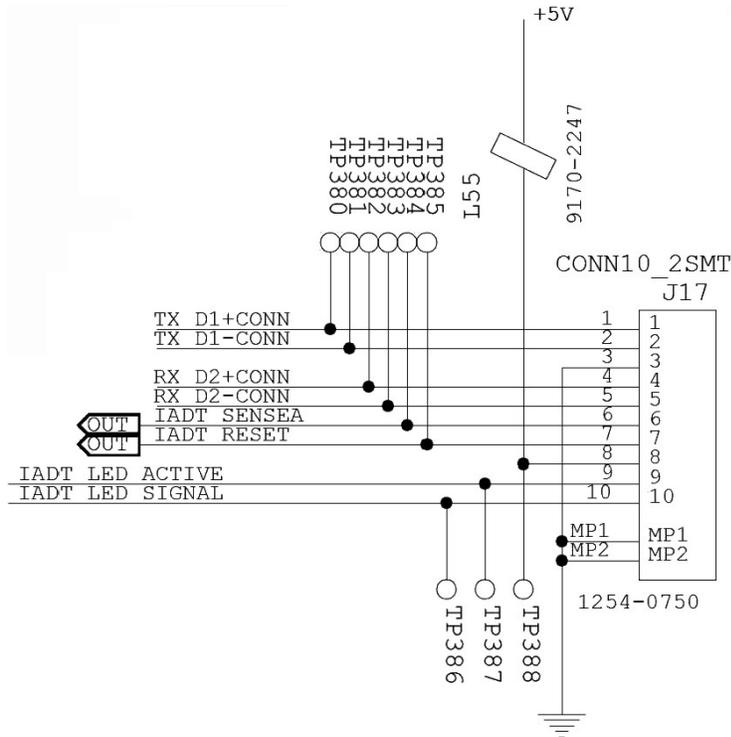
Figure 7 iADT port schematic

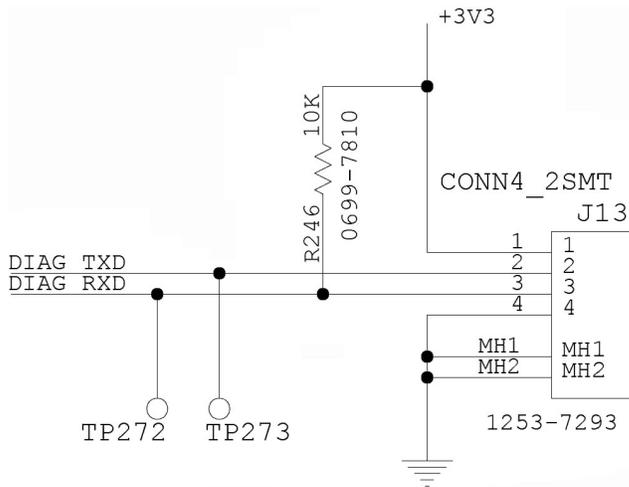
For products with two serial ports the same connector pin-out is used on both ports. The serial ports are identical to those on previous HP LTO products.

Figure 8 Diagnostic Serial Port connector schematic

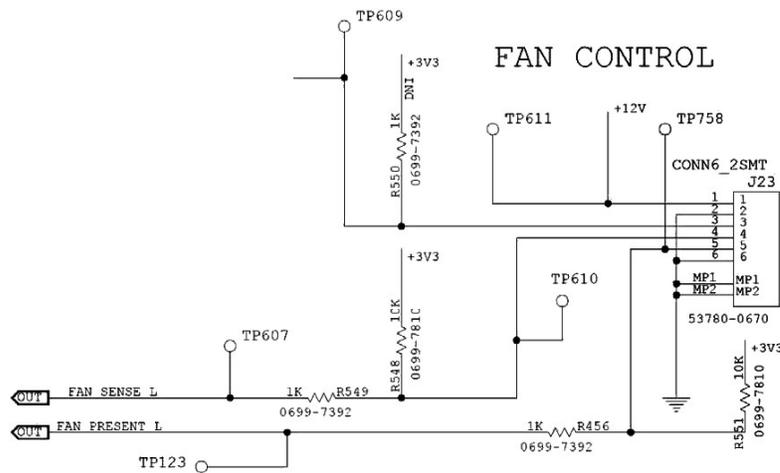
Figure 9 Fan connector schematic

- FAN SENSE is used to detect fan rotation.
- FAN PRESENT is used to detect that a fan has been connected to the drive. A fan is deemed to be present when this line is grounded. To achieve this, it is recommended that Pins 5 and 6 are tied together on the mating half of the connector.
- The power supply to the fan is a steady 12V.
- The fan speed is controlled via a PWM signal (pin3).
- A four-wire fan is required.

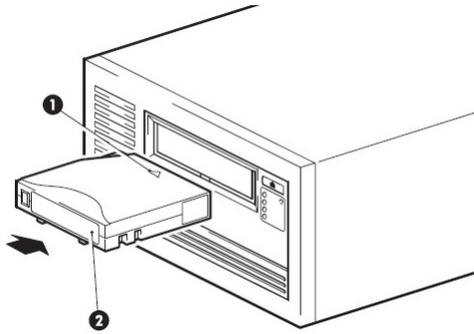
Full-height drives:

1. Arrow indicating leading direction
2. Cartridge label area

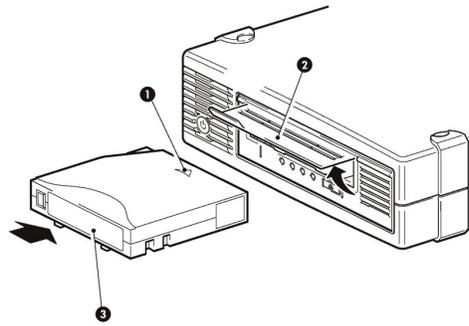
Half-height drives:

1. Arrow indicating leading direction
2. Drive door
3. Cartridge label area

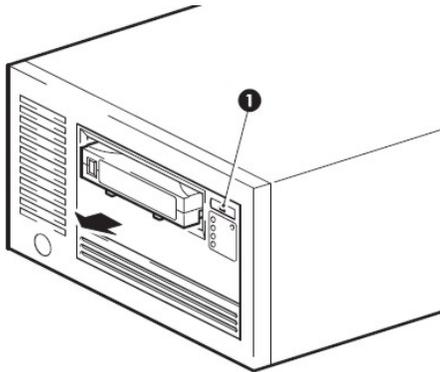
Full-height drives:

1. Eject button

1. Press the Eject button on the front panel.
During the unload sequence the READY LED flashes green. The drive completes any task it is currently performing, winds the tape to the beginning and ejects the cartridge. Once the tape has rewound, the eject cycle will take less than 13 seconds.
2. Remove the cartridge and store it in its plastic case in a cool, dry atmosphere.

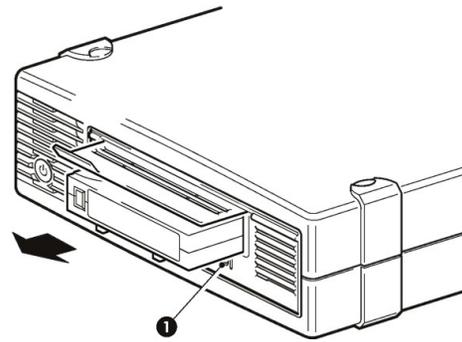
Half-height drives:

1. Eject button

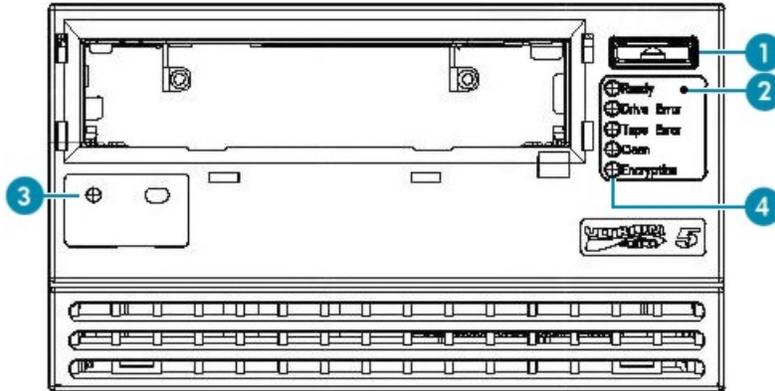
Full-height drives

- 1. Eject button
- 2. Access hole for emergency reset switch
- 3. Holes for optical sensors
- 4. LEDs

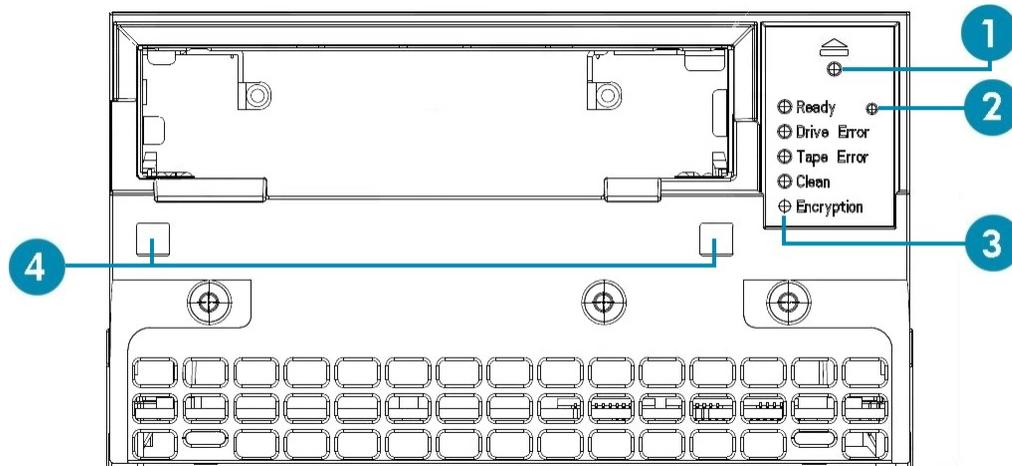
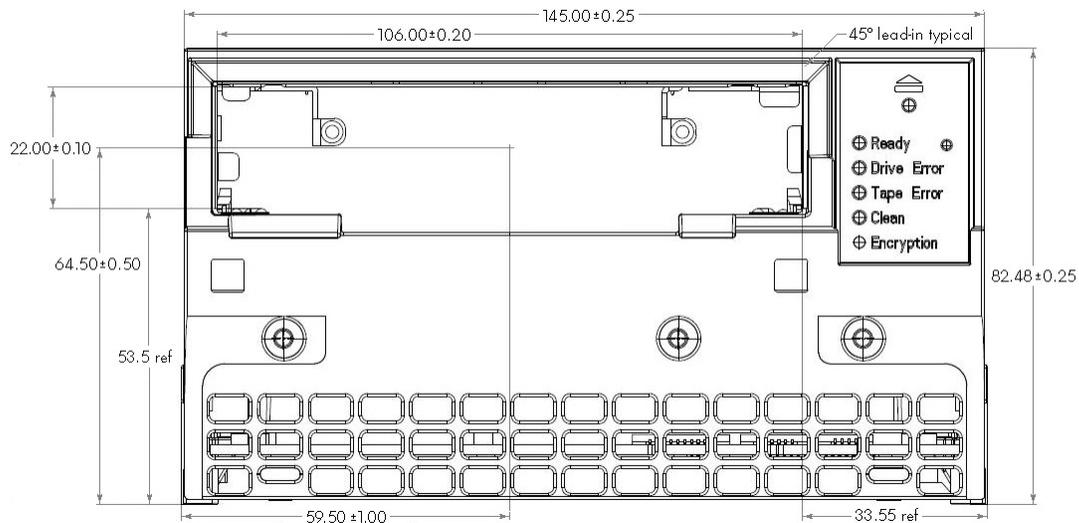
A special front panel is available for autoloader applications. The front panel fits within the drive form factor in height and width:

1. Access to Eject button
2. Access hole for emergency reset switch
3. LEDs
4. Access to datum surfaces on the front of the drive

- Simple one-piece plastic design
- Pinhole access to the eject switch on the drive for manually ejecting a cartridge. Press this for approximately ten seconds to start a “forced eject” for recovering a cartridge manually. See “[Emergency unload](#)” on page 61 for details.
- Indicator LEDs provide a visible indicator of the state of health of the drive. See “[Other LED patterns](#)” on page 23 for details. The LEDs are viewed through holes in the autoloader front panel; no light pipes are present.
- Clearance for picker finger access to the right-side cartridge-handling notch
- Two square holes through the panel to provide access to a datum surface on the front of the drive
- Cartridge lead-in features to improve cartridge load and unload operations

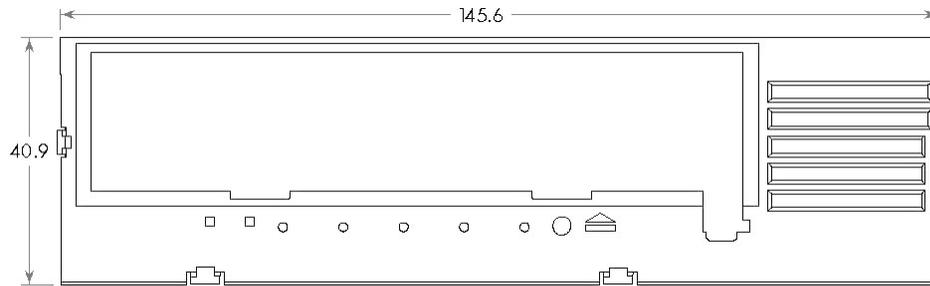
The half-height automation panel has very similar features to the full-height version. The exterior dimensions of the panel are smaller than those of the equivalent panels for drives designed for installing on servers and panels for standalone drives, in order to allow the whole drive to be fitted into the half-height form factor with no overlap.

Figure 10 Half-height automation bezel

The bezel is 4.1 mm thick.

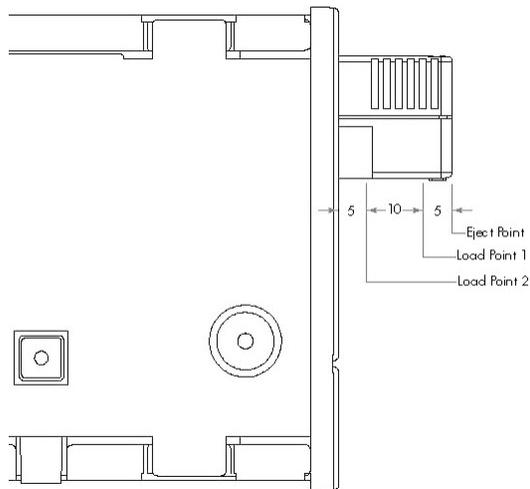
The following diagrams show the positions of importance during load and unload.

Figure 11 Full-height drives: load and unload positions

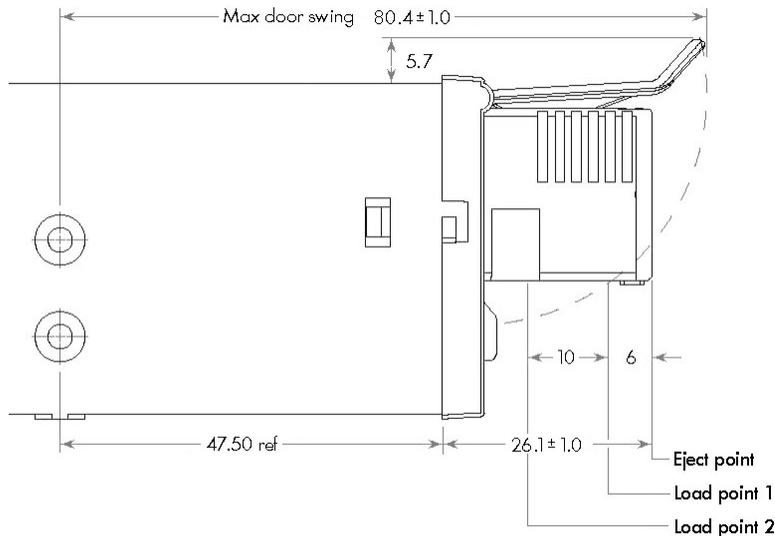
Figure 12 Half-height drives: load and unload positions

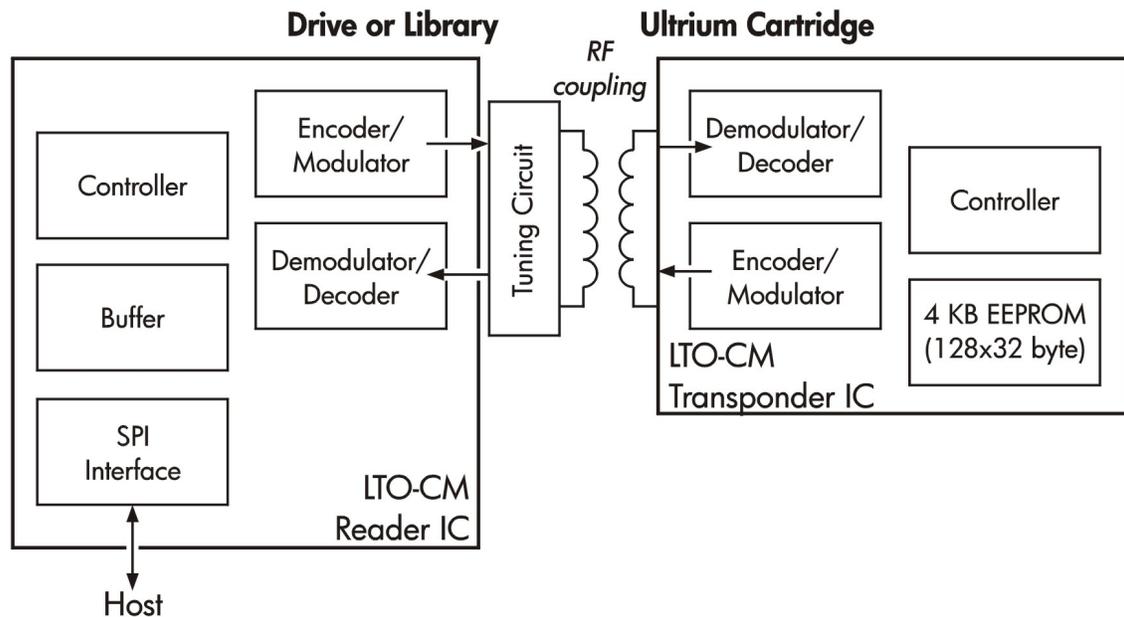
Cartridge memory offers possibilities for use in libraries as an adjunct to or replacement for barcodes. The following diagram shows the architecture required.

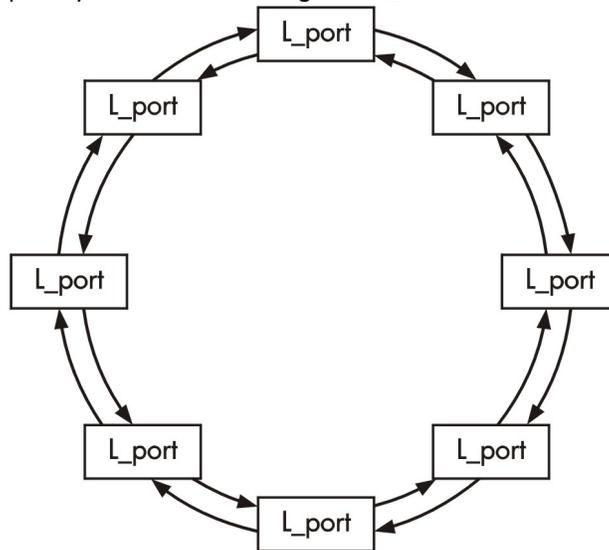
arbitrated loop One of the three Fibre Channel topologies. Up to 126 NL_ports and 1 FL_port, or 127 NL_ports, are configured in a unidirectional loop. Ports arbitrate for access to the loop based on their AL_PA. Ports with lower AL_PAs have higher priority than those with higher AL_PAs.
