# SPARC T4-2 Server

## Product Notes

Part No.: E23080-13  
July 2014

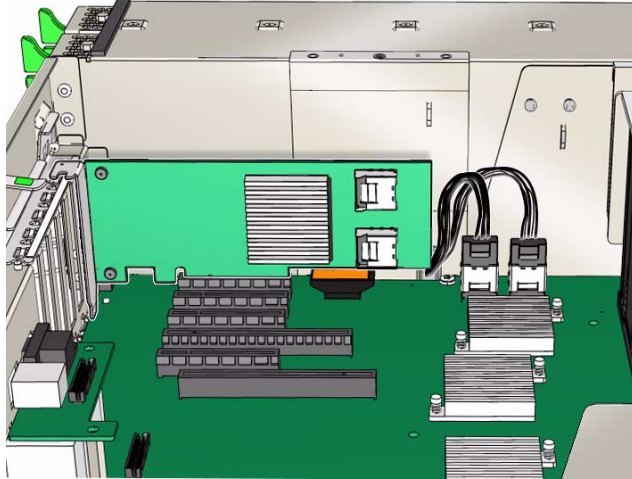
**Note** – If you install the HBA in PCIe slot 1, *PCIe slot 0 must remain unpopulated* to ensure proper system cooling.

2. Unplug the SAS data cable from the connector marked DISK0-3 on the motherboard.
3. Plug the SAS data cable into the upper connector on the HBA.
