Replacing an SFP Transceiver in the 6180 Array Module Configuration

51574-00, Rev. A

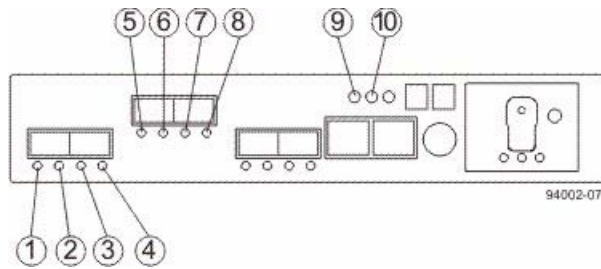
Figure 1 Host Channel Speed LEDs on the 6180 Controller CRU

- 1 Host Channel LED 0 for Port 1
- 2 Host Channel LED 1 for Port 1
- 3 Host Channel LED 0 for Port 2
- 4 Host Channel LED 1 for Port 2
- 5 Host Channel LED 0 for Port 3
- 6 Host Channel LED 1 for Port 3
- 7 Host Channel LED 0 for Port 4
- 8 Host Channel LED 1 for Port 4
- 9 Controller Service Action Allowed LED (Blue)
- 10 Controller Service Action Required LED (Amber)

- c** Save all the packing materials in case you need to return the SFP transceiver.
- 5** To locate a failed SFP transceiver in the 6180 array module, look at the Host Channel Speed LEDs on the rear of the controller canisters ([Figure 1](#)). Both Host Channel Speed LEDs for a particular port are off if an SFP transceiver has failed.

- **If both Host Channel LEDs are off for a particular port** – You must replace the SFP transceiver. Go to step 6.
- **If at least one Host Channel LED is on for a particular port** – The SFP transceiver is functional. The Host LEDs indicate a channel speed of 1 Gb/s, 2 Gb/s, 4 Gb/s, 8 Gb/s, or 10 Gb/s.

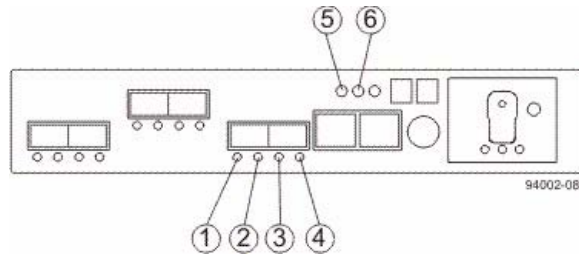
Figure 2 Drive LEDs on the 6180 Controller CRU

- 1 Drive Channel Link LED for Port 0 (Amber)
- 2 Drive Channel LED for Port 0 (Green)
- 3 Drive Channel LED for Port 1 (Green)
- 4 Drive Channel Link LED for Port 1 (Amber)
- 5 Controller Service Action Allowed LED (Blue)
- 6 Controller Service Action Required LED (Amber)

- 6 Check the Drive Channel LEDs on the rear of the 6180 controller CRU to locate the failed SFP transceiver (Figure 2). Both Drive Channel LEDs for a particular port are off if an SFP transceiver has failed.

- **If all of the Drive LEDs are off for a particular port on the array module** – You must replace the SFP transceiver. Go to step 7.
 - **If any Drive Channel Speed LED is on** – The SFP transceiver is functional. The Drive Channel Speed LEDs indicate a channel speed of 1 Gb/s, 2 Gb/s, 4 Gb/s, 8 Gb/s or 10 Gb/s. The Drive Channel Link LEDs are amber when a link is not sensed. Go to step 7.
- 7** On the CSM200 drive module, check the Drive Channel Speed LEDs on the rear of the ESM/IOM CRU to locate the failed SFP transceiver (Figure 3). Both Drive Channel Speed LEDs for a particular port are off if an SFP transceiver has failed.

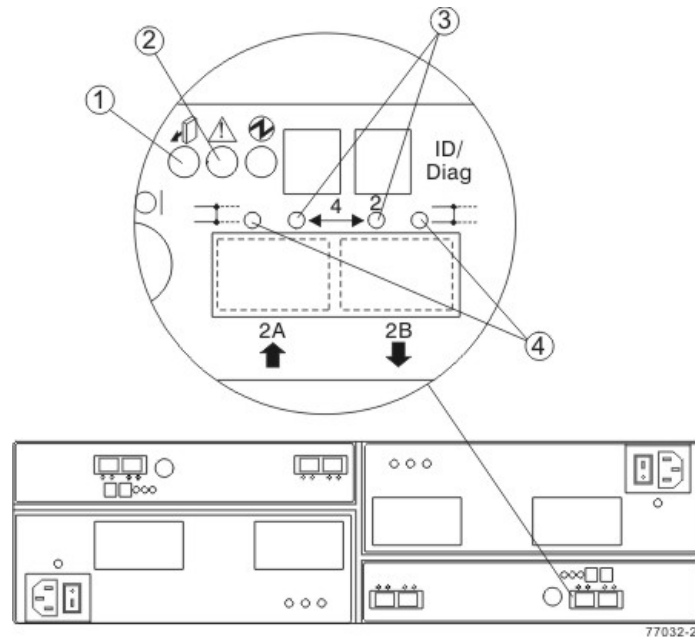
Figure 3 ESM/IOM LEDs on the CSM200 Drive Module

- 1 ESM Service Action Allowed LED (Blue)
- 2 ESM Service Action Required LED (Amber)
- 3 Drive Channel Speed LEDs
- 4 Link LEDs

- **If all of the Drive Channel Speed LEDs are off for a particular port on the drive module** – You must replace the SFP transceiver. Go to step 8.
 - **If any Drive Channel Speed LED is on** – The SFP transceiver is functional. The Drive Channel Speed LEDs indicate a channel speed of 1 Gb/s, 2 Gb/s, or 4 Gb/s. The ESM/IOM Link LED is amber when a link is not sensed.
- 8** If it is present, disconnect the fiber-optic cable from the failed SFP transceiver (Figure 4).

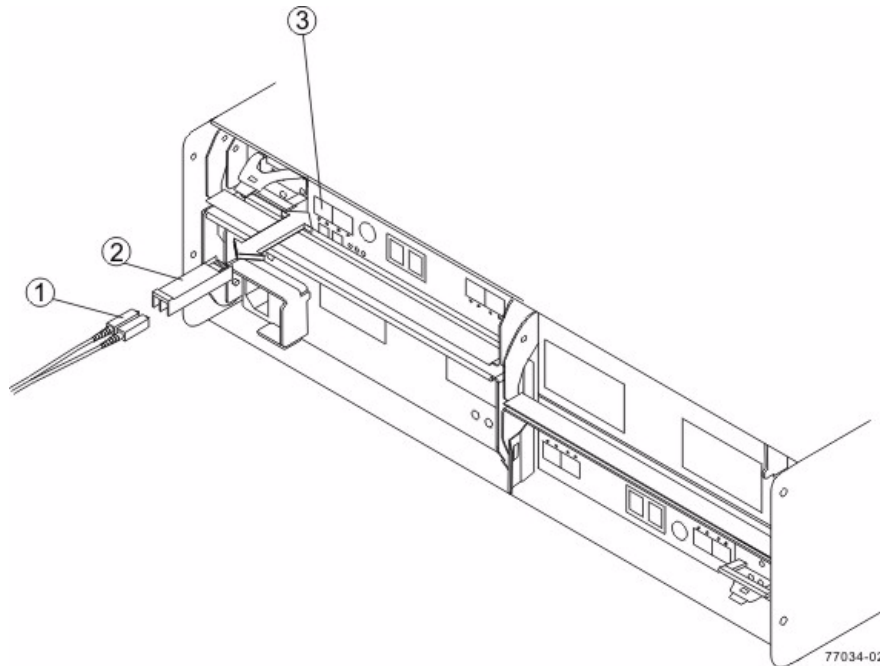
Figure 5 Removing an SFP Transceiver – CSM200 Drive Module

- 1 Fiber-Optic Cable
- 2 SFP Transceiver
- 3 Drive Interface Port

- 9** Remove the failed SFP transceiver from the appropriate interface port (Figure 5).
