Sun Flash Accelerator F40 PCIe Card Product Notes

Part No: E29742-12
March 2017

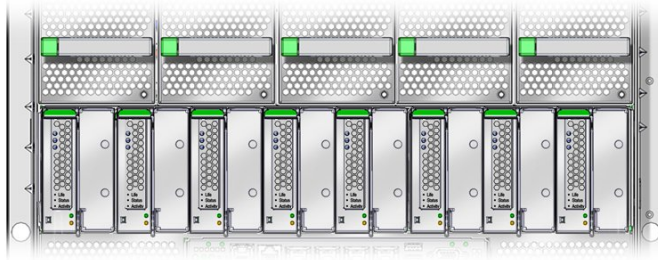
The following figure shows an example of doublewide PCIe hot plug carrier extensions that populate two PCIe slots for each Sun Flash Accelerator F40 PCIe Card.
