Sun Server X4-2L Product Notes

Part No: E38146-26
May 2019

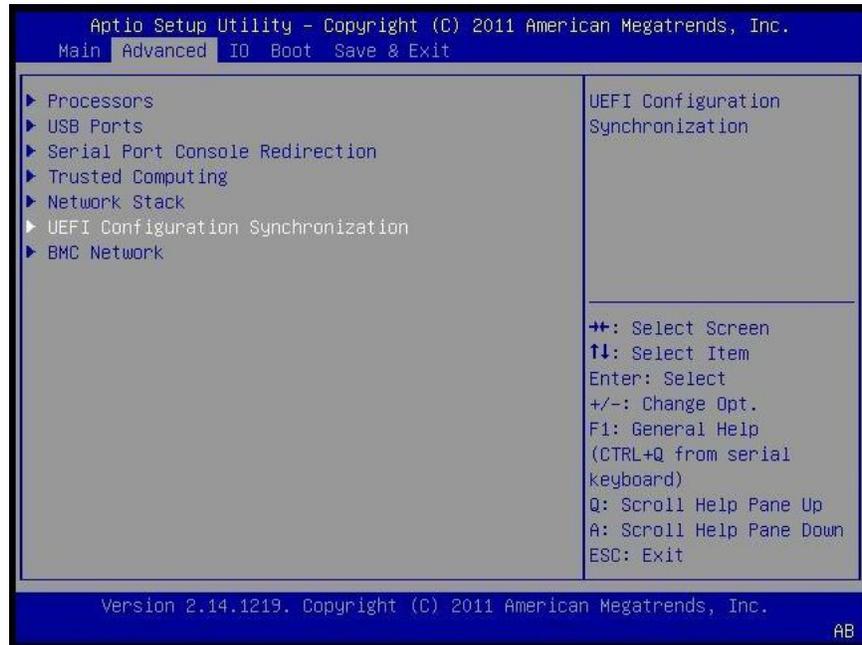
- Log in to Oracle ILOM Remote Console or connect your monitor directly to a system to access the BIOS Setup Utility. In the BIOS Setup Utility, click the Advanced tab and scroll down to UEFI Configuration Synchronization. Press Enter to open the UEFI Configuration Synchronization menu.

Synchronization Late is enabled by default. Press Enter to enable or disable Synchronization Late. Save and Exit the BIOS Setup Utility.

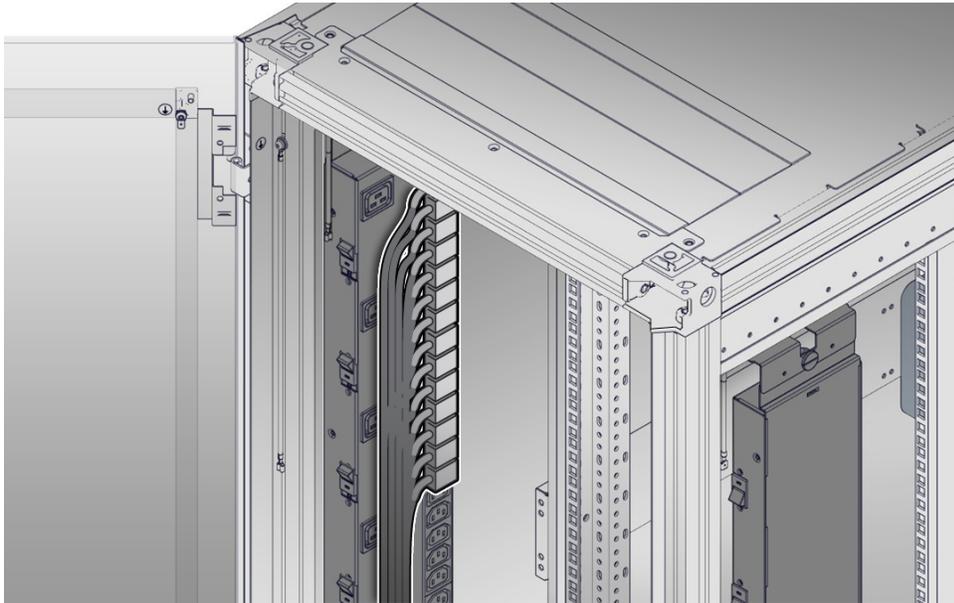
1. Prior to installing the slide-rails into the rack, install right-angle AC power cables into the left-side and right-side PDU electrical sockets for the servers you are going to rack mount.

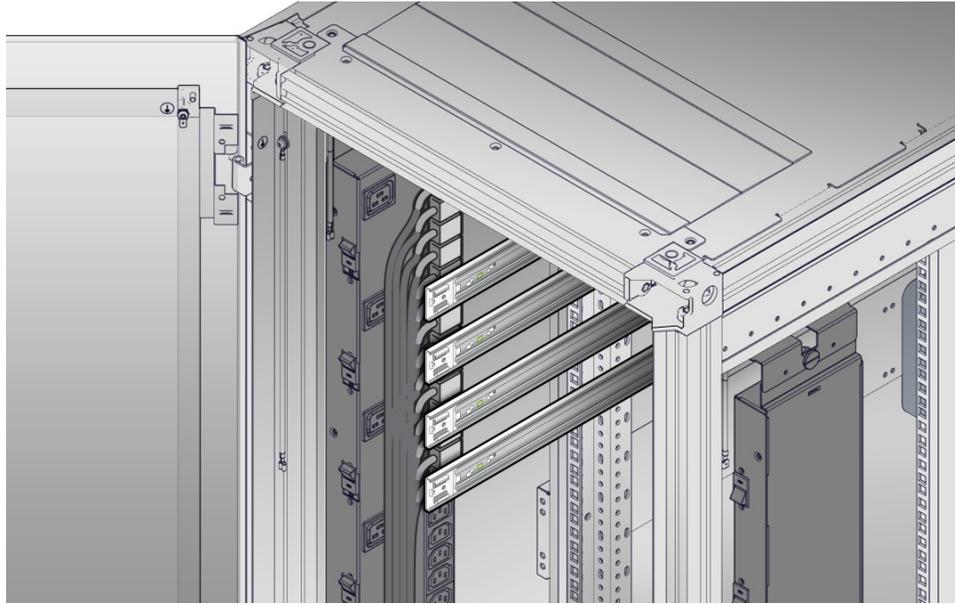
2. Install the slide-rails into the rack.

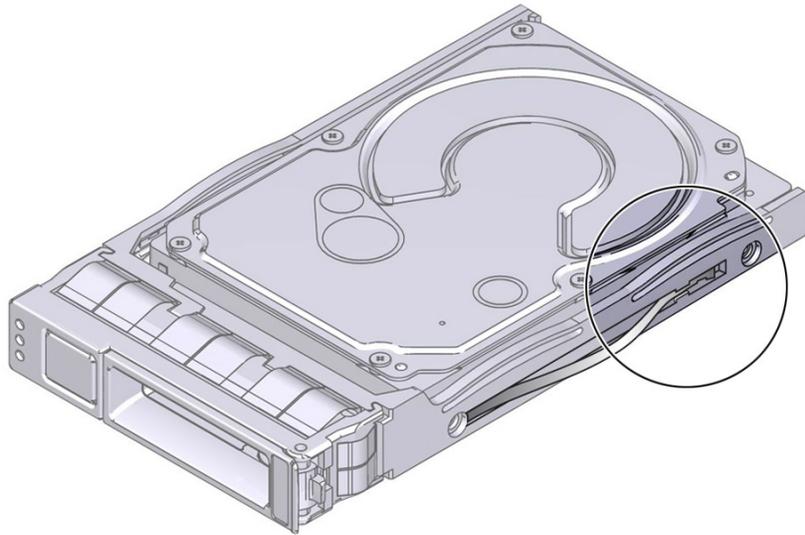
FIGURE 1 Grounding Strap Seated Correctly in the HDD Bracket

Before installing a 3.5-inch HDD into your system, visually inspect the grounding strap to ensure that the end of the strap is seated correctly in the HDD bracket. See the following figure for an example of a grounding strap that is seated correctly.

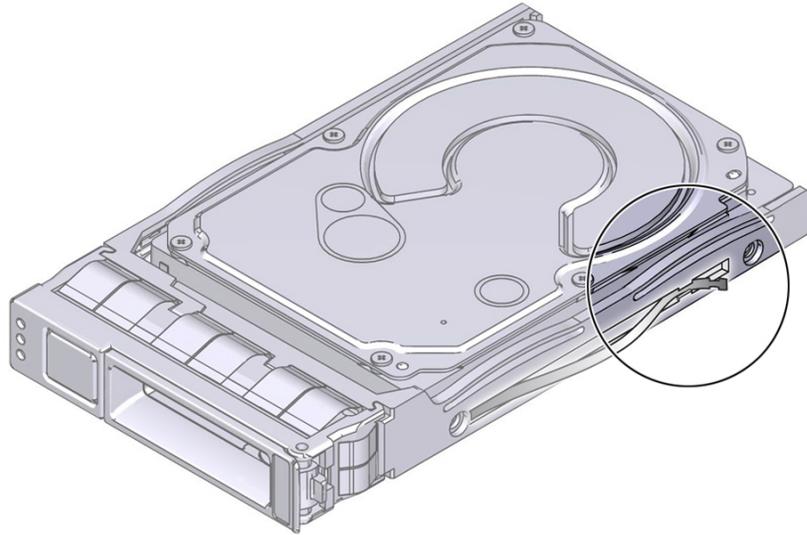
FIGURE 2 Grounding Strap Not Seated Correctly in the HDD Bracket

If the grounding strap is not seated correctly, or is protruding past the outer edge of the HDD bracket, the HDD bracket should be replaced. See the following figure for an example of a grounding strap that is not seated correctly.

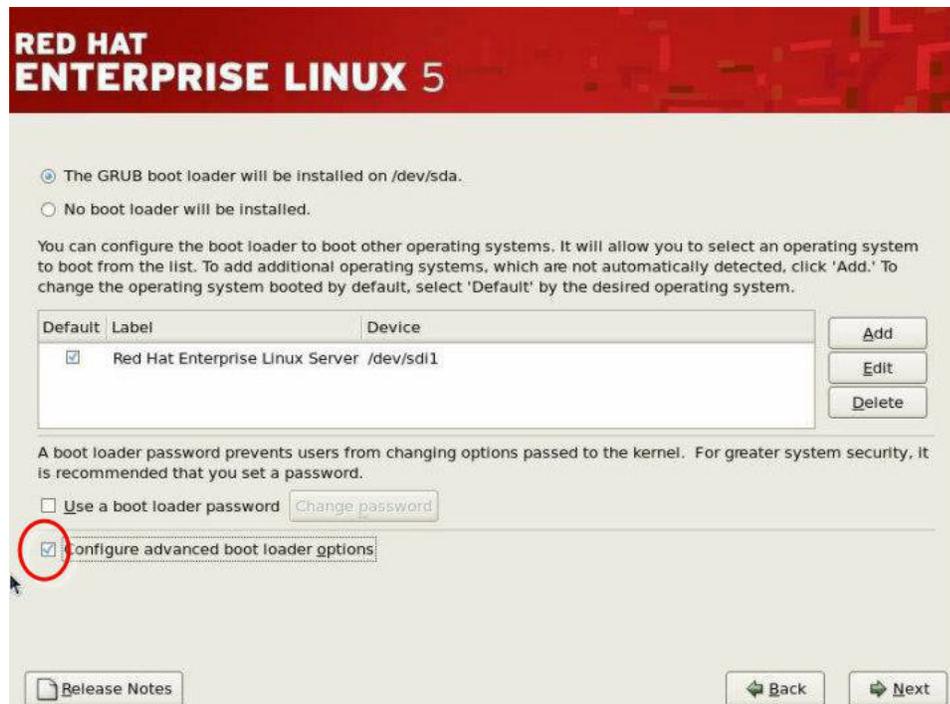
1. **Proceed with the Oracle Linux 5 or RHEL 5 installation until the GRUB boot loader screen appears.**

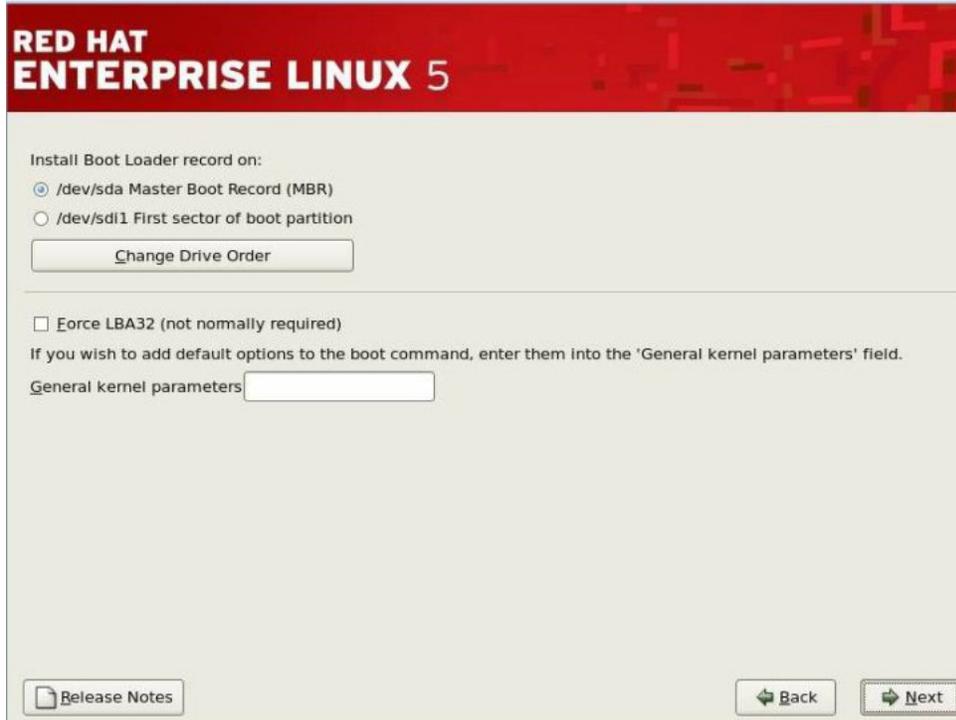
2. **In the GRUB boot loader screen, check the box for “Configure advanced boot loader options,” and click Next.**

The “Install Boot Loader record on” screen appears.

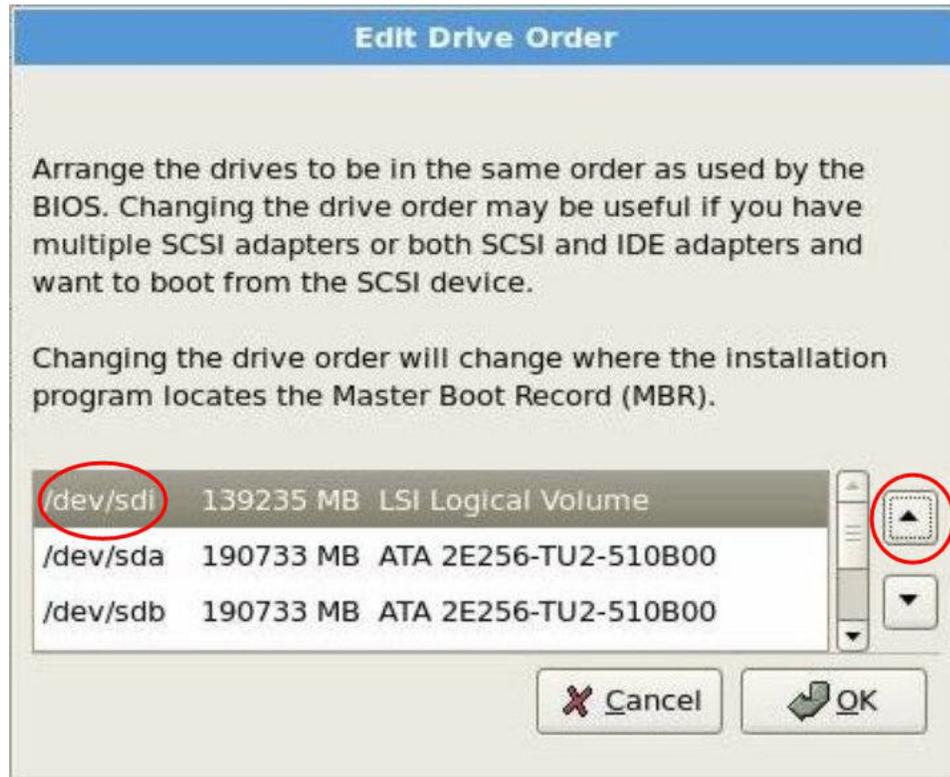
3. In options for "Install Boot Loader record on" in the top portion of the screen, click Change Drive Order.

The Edit Drive Order dialog box appears.

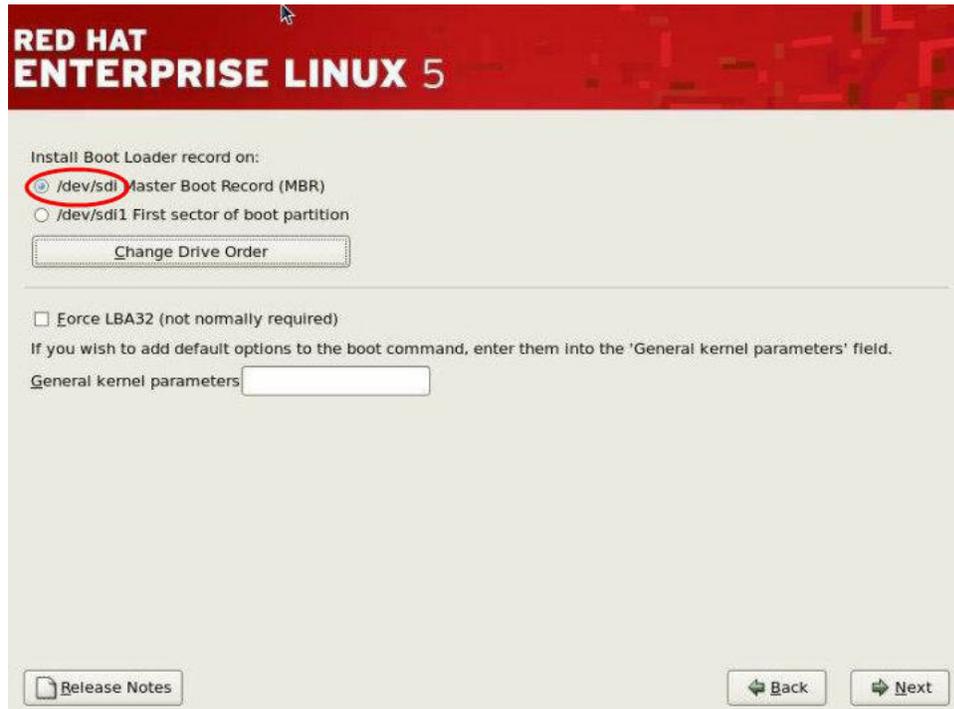
The updated “Install Boot Loader record on” screen appears.

5. In the updated “Install Boot Loader record on” screen, note that the “Install boot loader record on” option is set to the target HDD's MBR that you selected.
6. Click Next to finish the installation.
