Release Notes for Oracle Fabric Interconnect and XgOS 3.9.1

These release notes document information about the Oracle Fabric Interconnect F1-15 and F1-4 and version 3.9.1 of Oracle's XgOS command-line interface. Additional release notes exist for:

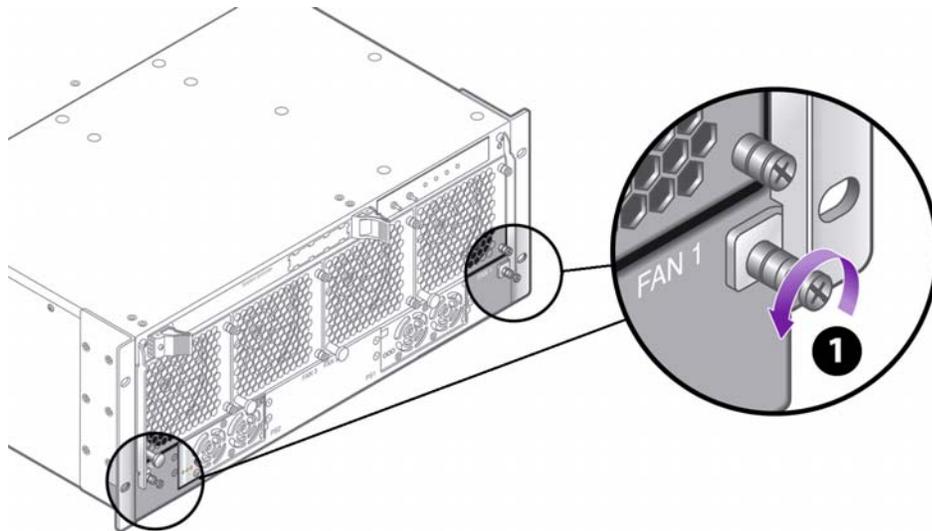
- Step 1** Power down the Fabric Interconnect.
- Step 2** Using the screwdriver, release the two spring-loaded screws (1) securing the release levers to the chassis. See [Figure 1](#).

Figure 1 Loosening the Fabric Interconnect F1-15 Front Panel Assembly Screws

- Step 3 When the FP-2 plug has contacted the socket inside the chassis, simultaneously grasp both of the release levers and slowly lower them until they are vertical and flush with the chassis. This step is the reverse of (2) in [Figure 2](#).
- Step 4 Using the screwdriver, tighten the two spring-loaded screws securing the release levers to the chassis. This step is the reverse of [Figure 1](#). *Do not overtighten the screws!*
- Step 5 Power on the system.
- Step 6 As an option, you can attach to serial port 1 (SER-1) at 115200 baud and leave the session open to watch the progress of the installation and start up while the Fabric Interconnect is brought back online.
- Step 7 When the chassis is up, log on as `admin/admin`.

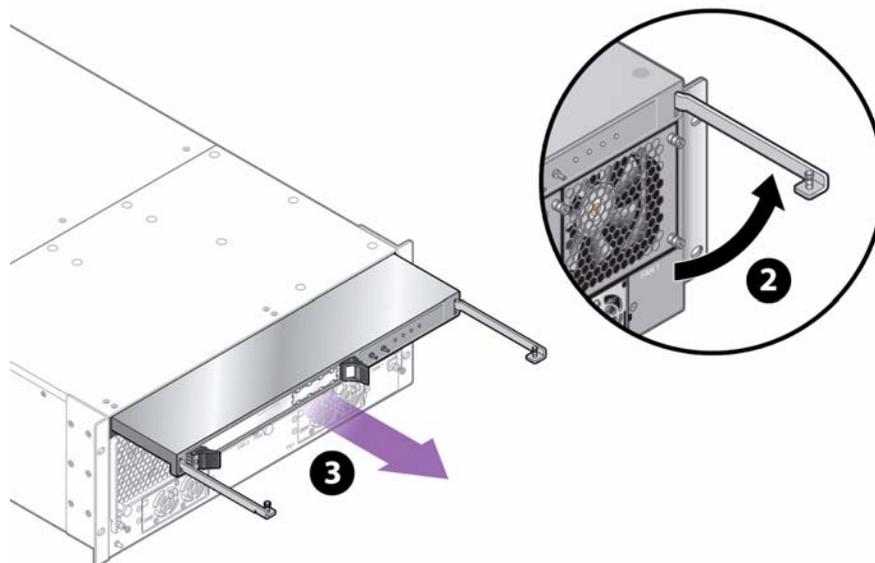
- Step 3** Simultaneously grasp both of the release levers and slowly raise them until they are horizontal (2), then use the levers to carefully slide the assembly out of the chassis (3). See [Figure 2](#).

Figure 2 Removing the Fabric Interconnect F1-15 Front Panel Assembly

- Step 1 Carefully align the FP-2 with the Front Panel bay in the chassis. Make sure that the FP-2 is facing up, and the handles are pointing straight towards you as shown in (3) in [Figure 2](#).
- Step 2 Keeping the FP-2 level and holding it by the edges, gently slide the FP-2 into the chassis until you feel some resistance when the FP-2 is almost all the way inserted.
