Release Notes for Oracle Fabric Interconnect and XgOS 3.9.2

These release notes document information about the Oracle Fabric Interconnect F1-15 and F1-4 and version 3.9.2 of Oracle's XgOS command-line interface. Additional release notes exist for:

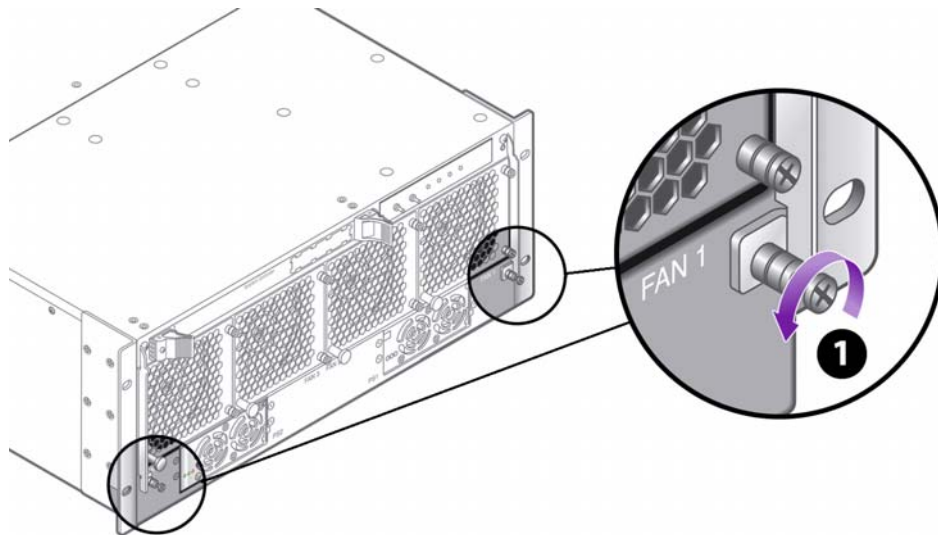
- Step 1** Power down the Fabric Interconnect.
- Step 2** Using the screwdriver, release the two spring-loaded screws (1) securing the release levers to the chassis. See [Figure 1](#).

Figure 1 Loosening the Fabric Interconnect F1-15 Front Panel Assembly Screws

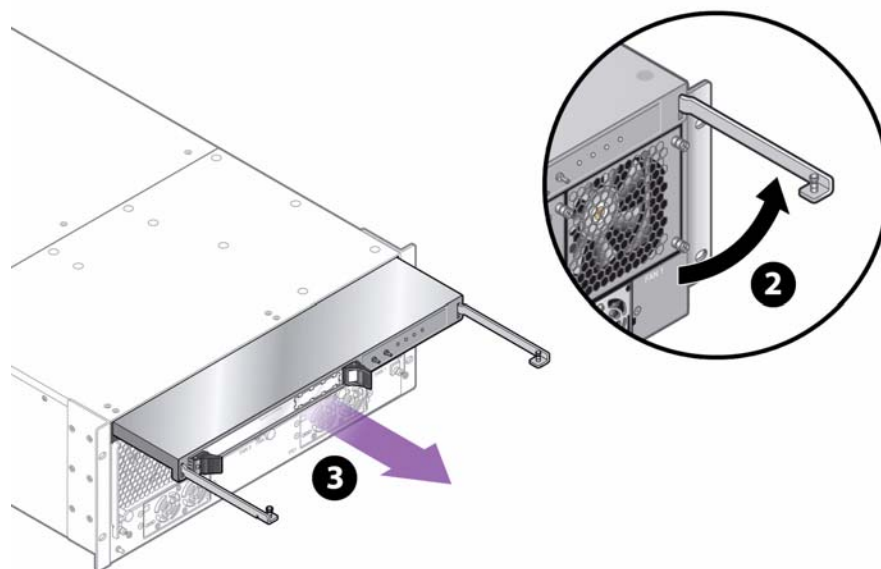
- Step 3** Simultaneously grasp both of the release levers and slowly raise them until they are horizontal (2), then use the levers to carefully slide the assembly out of the chassis (3). See [Figure 2](#).

Figure 2 Removing the Fabric Interconnect F1-15 Front Panel Assembly

- Step 1 Carefully align the FP-2 with the Front Panel bay in the chassis. Make sure that the FP-2 is facing up, and the handles are pointing straight towards you as shown in (3) in [Figure 2](#).
- Step 2 Keeping the FP-2 level and holding it by the edges, gently slide the FP-2 into the chassis until you feel some resistance when the FP-2 is almost all the way inserted.

- Step 3 When the FP-2 plug has contacted the socket inside the chassis, simultaneously grasp both of the release levers and slowly lower them until they are vertical and flush with the chassis. This step is the reverse of (2) in [Figure 2](#).
- Step 4 Using the screwdriver, tighten the two spring-loaded screws securing the release levers to the chassis. This step is the reverse of [Figure 1](#). *Do not overtighten the screws!*
- Step 5 Power on the system.
- Step 6 As an option, you can attach to serial port 1 (SER-1) at 115200 baud and leave the session open to watch the progress of the installation and start up while the Fabric Interconnect is brought back online.
- Step 7 When the chassis is up, log on as `admin/admin`.
