Oracle® Private Cloud Appliance

Release Notes for Release 2.2.1

E71898-03
October 2016

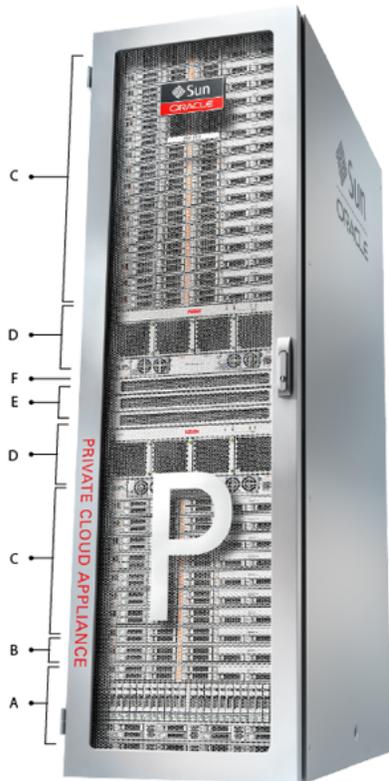
Figure 1.1 Components of an Oracle Private Cloud Appliance Rack

The Oracle PCA consists of a Sun Rack II 1242 base, populated with the hardware components identified in [Figure 1.1](#).

Item	Quantity	Description
A	1	Either Oracle ZFS Storage Appliance ZS3-ES or Sun ZFS Storage Appliance 7320
B	2	Either Oracle Server X5-2, Sun Server X4-2, or Sun Server X3-2, used as management nodes

The initial version of the Oracle Private Cloud Appliance, the X3-2 base rack, was shipped with the Sun ZFS Storage Appliance 7320. This hardware component has since been replaced with the Oracle ZFS Storage Appliance ZS3-ES. Software support for the Oracle ZFS Storage Appliance ZS3-ES is available as of Release 1.1.3. All software releases continue to support the Sun ZFS Storage Appliance 7320.
