Oracle® Private Cloud Appliance

Release Notes for Release 2.3.3

E92215-02
August 2018

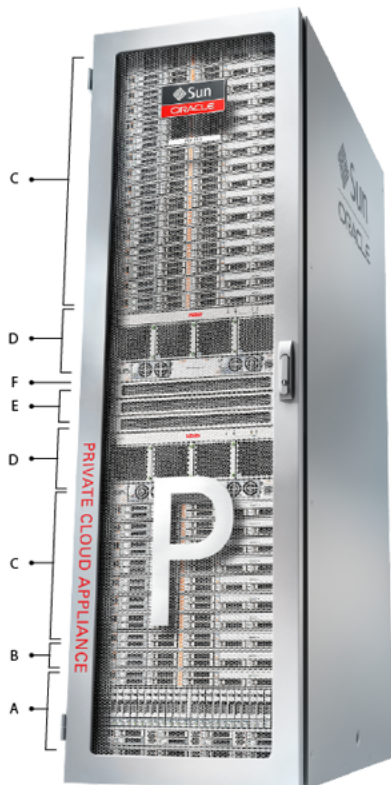
Figure 1.1 Components of an Oracle Private Cloud Appliance Rack

The Oracle PCA consists of a Sun Rack II 1242 base, populated with the hardware components identified in [Figure 1.1](#).

Item	Quantity	Description
A	1	Either Oracle ZFS Storage Appliance ZS5-ES, Oracle ZFS Storage Appliance ZS3-ES, or Sun ZFS Storage Appliance 7320
B	2	Either Oracle Server X5-2, Sun Server X4-2, or Sun Server X3-2, used as management nodes
C	2-25	Either Oracle Server X7-2, Oracle Server X6-2, Oracle Server X5-2, Sun Server X4-2, or Sun Server X3-2, used as virtualization compute nodes (Due to the higher power requirements of the Oracle Server X7-2, Oracle Server X6-2 and Oracle Server X5-2, if the appliance is equipped with 22kVA PDUs, the maximum number of compute nodes is 23.)
D	2	Oracle Fabric Interconnect F1-15
E	2	NM2-36P Sun Datacenter InfiniBand Expansion Switch
F	2	Oracle Switch ES1-24

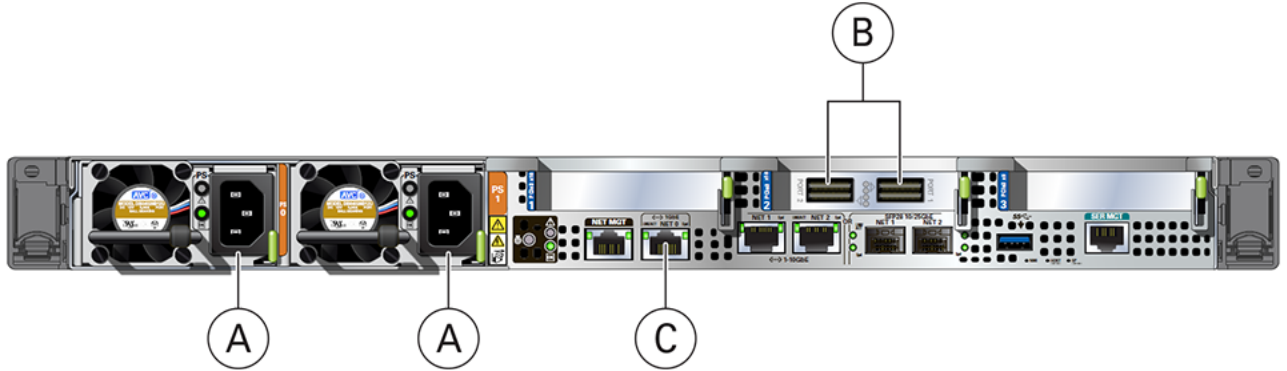
Figure 5.1 Oracle Server X7-2 Cabling Requirements

After installing an Oracle Server X7-2 into the appliance rack, it should be connected using the same pre-installed cables and the equivalent ports on the back of the server. The following two images illustrate the subtle differences between both server models. The letters indicate where the required cables must be connected, and the figure legend below identifies the ports and their purpose.

Item	Description
A	Power supplies
B	InfiniBand connectors
C	NET0 Ethernet port
