# Oracle® Private Cloud Appliance

## Release Notes for Release 2.4.2

F23454-05  
March 2020

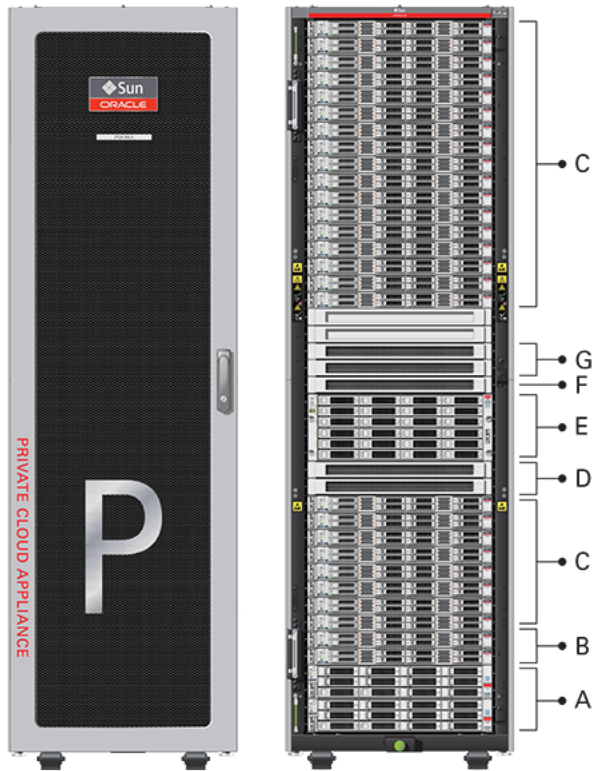
**Figure 1.1 Components of an Oracle Private Cloud Appliance Rack**

The Oracle Private Cloud Appliance consists of an Oracle Rack Cabinet 1242 base, populated with the hardware components identified in [Figure 1.1](#).

**Table 1.1 Figure Legend**

Item	Quantity	Description
A	2	Oracle ZFS Storage Appliance ZS7-2 controller server
B	2	Oracle Server X8-2, used as management nodes
C	2-25	Oracle Server X8-2, used as virtualization compute nodes  (Due to the power requirements of the Oracle Server X8-2, if the appliance is equipped with 22kVA PDUs, the maximum number of compute nodes is 22. With 15KVA PDUs the maximum is 13 compute nodes.)
D	2	Cisco Nexus 9336C-FX2 Switch, used as leaf/data switches
E	1	Oracle ZFS Storage Appliance ZS7-2 disk shelf
F	1	Cisco Nexus 9348GC-FXP Switch
G	2	Cisco Nexus 9336C-FX2 Switch, used as spine switches
