# **Oracle® Private Cloud Appliance**

## **Release Notes for Release 2.4.3**

F28398-10  
March 2022

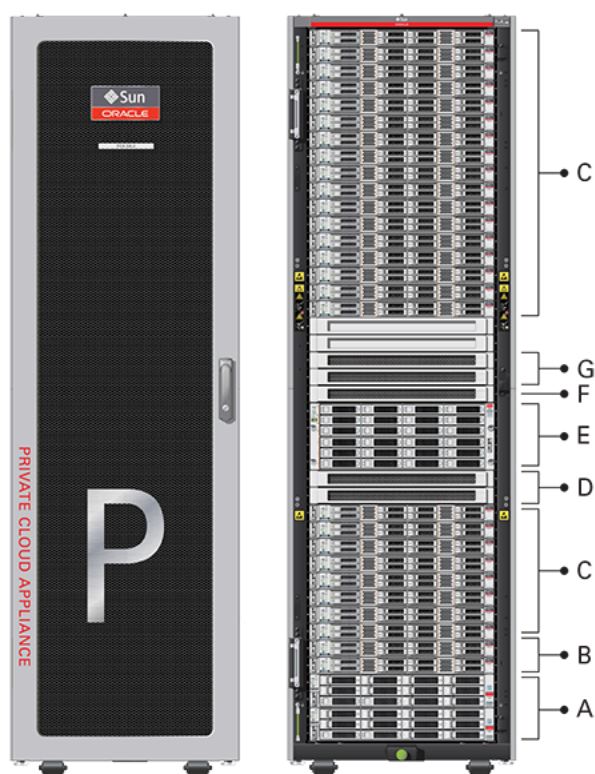
**Figure 1.1 Components of an Oracle Private Cloud Appliance Rack**

The Oracle Private Cloud Appliance consists of an Oracle Rack Cabinet 1242 base, populated with the hardware components identified in [Figure 1.1](#).

Item	Quantity	Description
A	2	Oracle ZFS Storage Appliance ZS7-2 controller server
B	2	Oracle Server X8-2, used as management nodes
C	2-25	Oracle Server X8-2, used as virtualization compute nodes  (Due to the power requirements of the Oracle Server X8-2, if the appliance is equipped with 22kVA PDUs, the maximum number of compute nodes is 22. With 15KVA PDUs the maximum is 13 compute nodes.)
D	2	Cisco Nexus 9336C-FX2 Switch, used as leaf/data switches
E	1	Oracle ZFS Storage Appliance ZS7-2 disk shelf
F	1	Cisco Nexus 9348GC-FXP Switch
G	2	Cisco Nexus 9336C-FX2 Switch, used as spine switches
