# Oracle Private Cloud Appliance

## Release Notes for Release 2.4.3.2

F79356-02  
August 2023

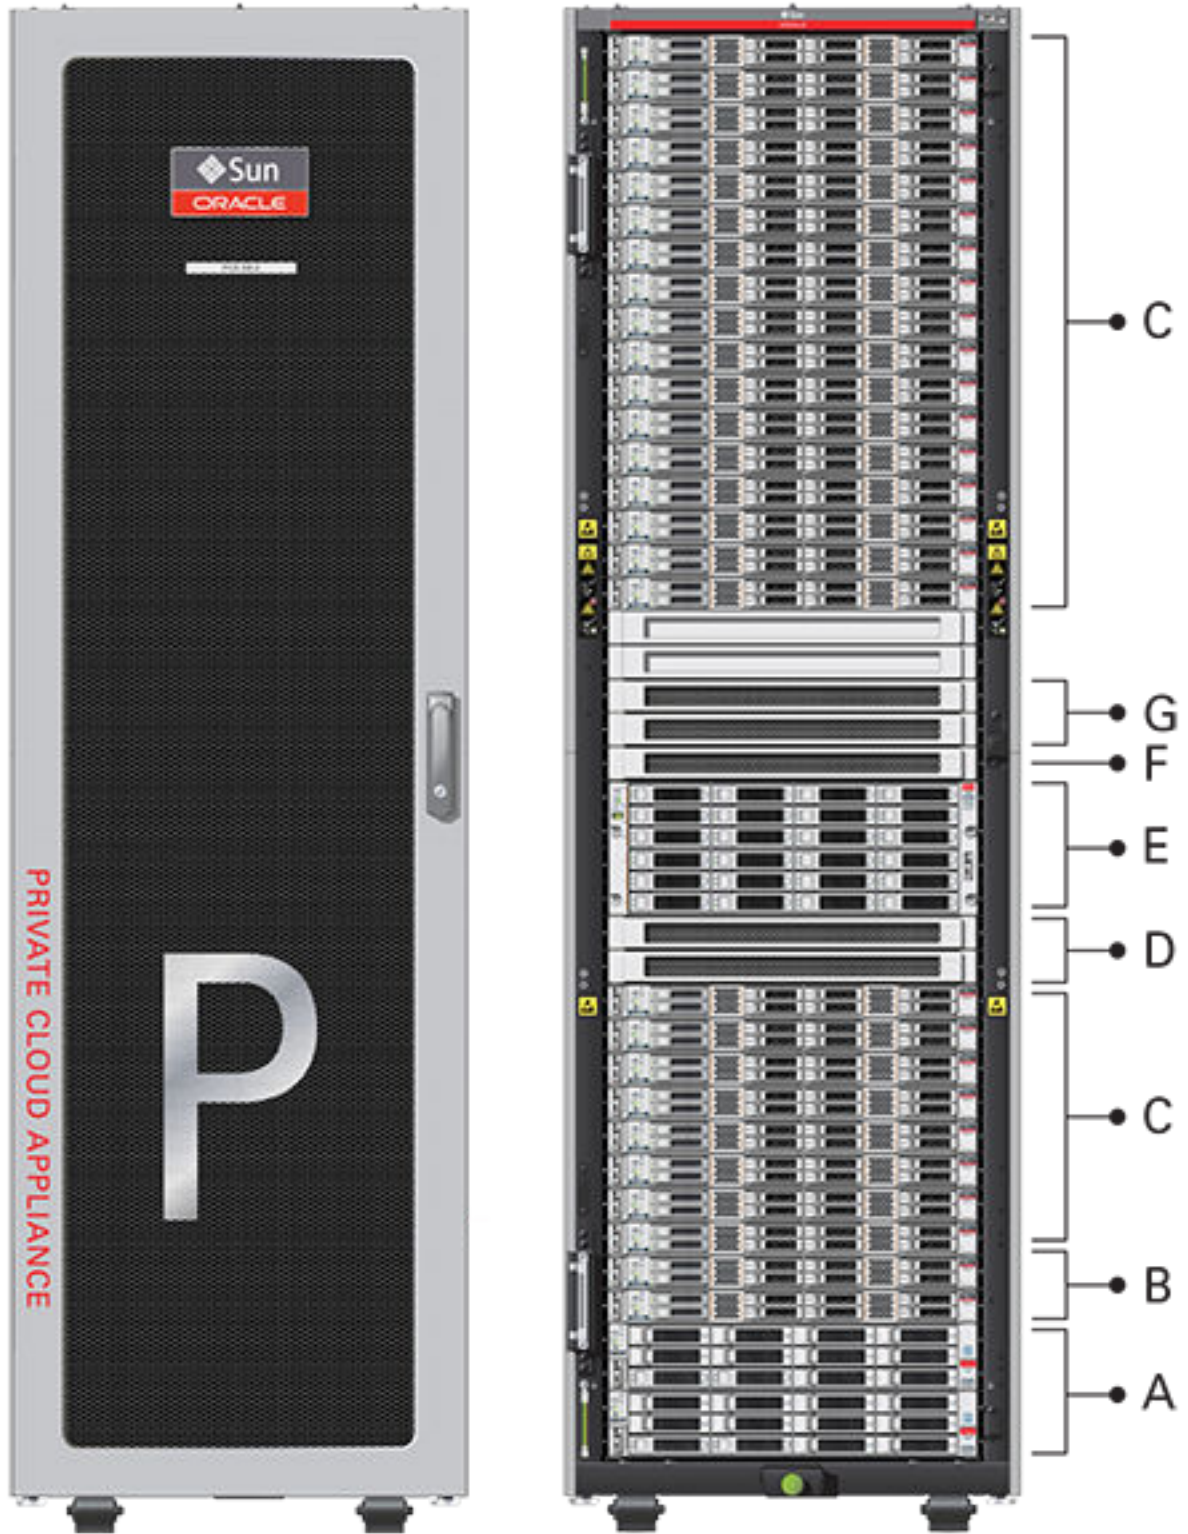
Components of an Oracle Private Cloud Appliance Rack

The Oracle Private Cloud Appliance consists of an Oracle Rack Cabinet 1242 base, populated with the hardware components identified in [#unique\\_11/unique\\_11\\_Connect\\_42\\_fig-relnotes-rackcomponents](#).

Item	Quantity	Description
A	2	Oracle ZFS Storage Appliance ZS7-2 controller server
B	2	Oracle Server X8-2, used as management nodes
C	2-25	Oracle Server X8-2, used as virtualization compute nodes (Due to the power requirements of the Oracle Server X8-2, if the appliance is equipped with 22kVA PDUs, the maximum number of compute nodes is 22. With 15KVA PDUs the maximum is 13 compute nodes.)
D	2	Leaf/data switches
E	1	Oracle ZFS Storage Appliance ZS7-2 disk shelf
F	1	Management switch
G	2	Spine switches
