Oracle® Server X5-2 Product Notes

Part No: E48321-24
August 2021

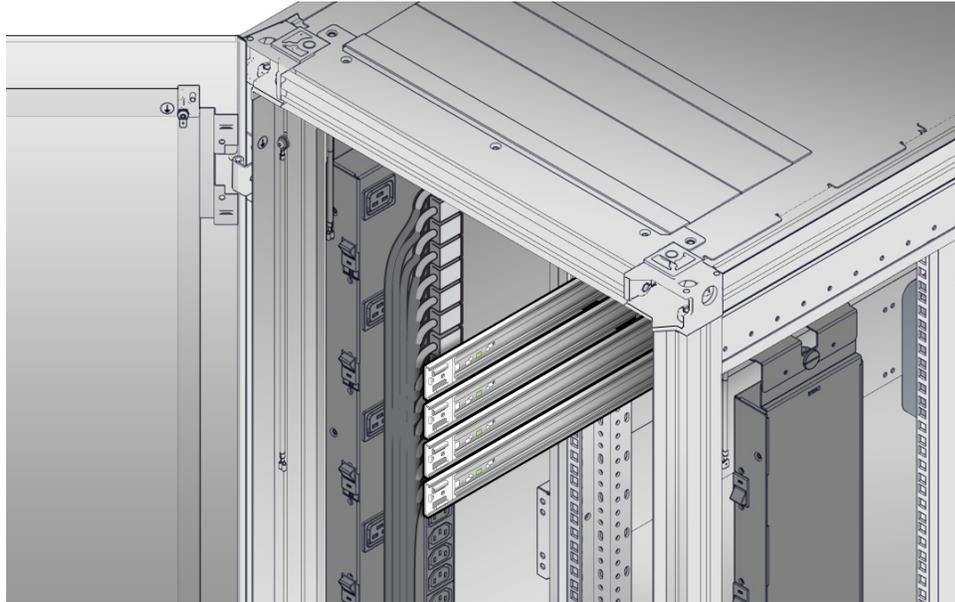
2. **Install the slide-rails into the rack.**

Refer to [“Attach Tool-less Slide-Rail Assemblies”](#) in *Oracle Server X5-2 Installation Guide*.

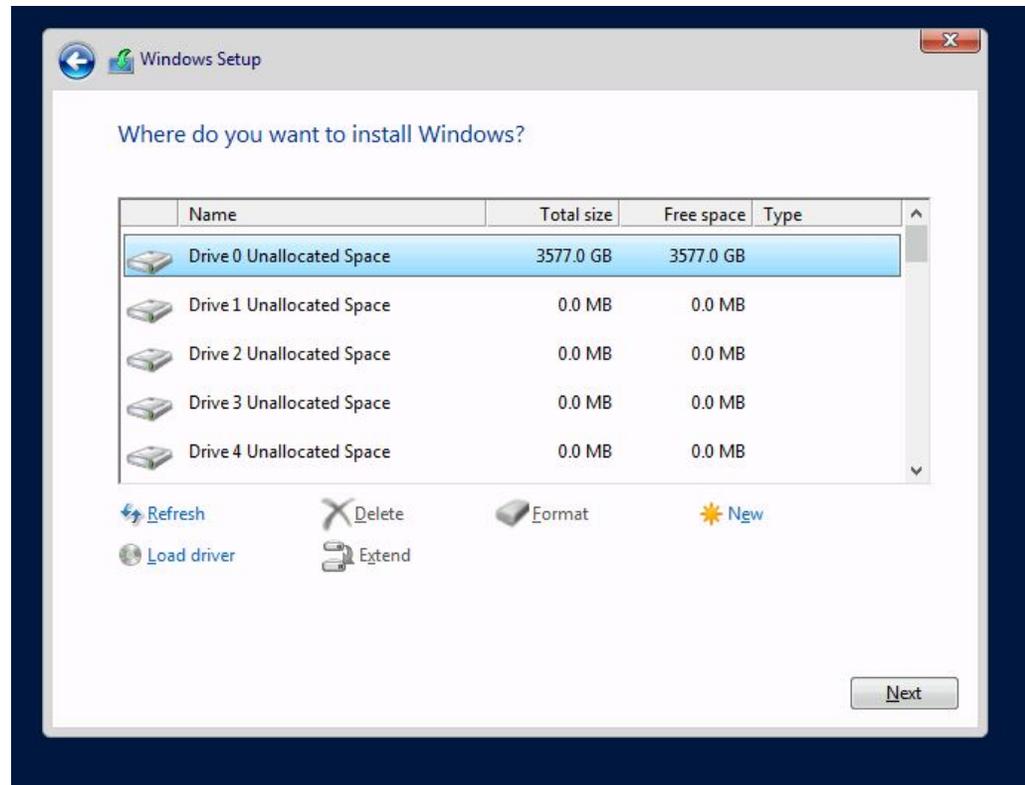
Issue: During Windows Server 2016 installation on a system with an NVMe storage drive, Windows Setup lists the NVMe storage device and 127 phantom listings of the same NVMe storage device. These phantom storage devices each show a total size and free space of 0.0 MB. For example:

After you install Windows Server 2016, the 127 phantom drives also appear in Windows Device Manager. This issue is due to an out-of-date inbox Windows Server 2016 NVMe driver that does not support the multiple namespace feature of some NVMe storage devices.
