# Sun StorageTek 6140 Array Release Notes

Release 2.0

Part No. 819-5044-10 June 2006, Revision A

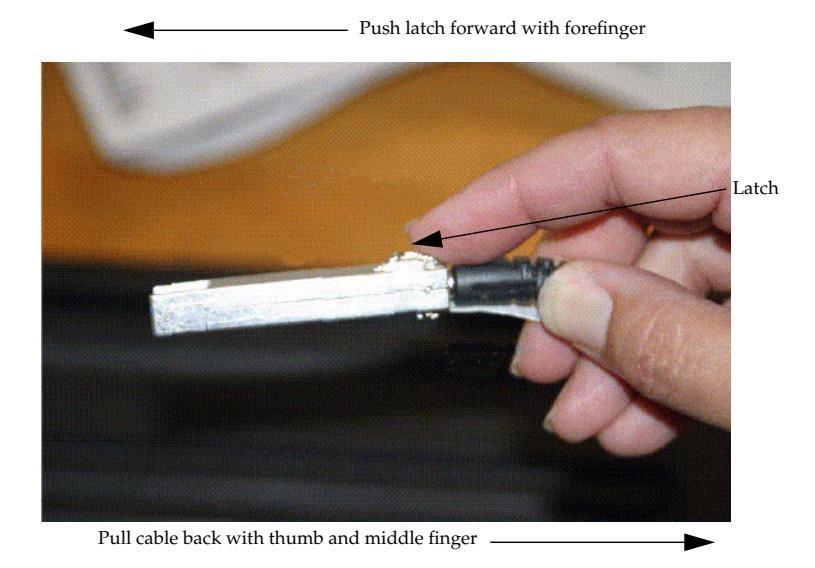
The adapter also has a latch on the top of it, that locks the cable into the port. FIGURE A-1 shows the cable end adapter with the latch being pushed forward.

FIGURE A-1 Cable End With Adapter and Latch

There is a metallic adapter on the cable end for plugging the cable into the port. The adapter has a tab on the underside for releasing and pulling the cable out of the slot, but on some cables the tab is too short (especially in the confined space at the rear of a controller).

To remove the cable from the port, you must push the latch forward and pull the cable back at the same time. In FIGURE A-1, the left arrow shows the latch being pushed left, and the right arrow shows the cable being pulled right. If space is tight at the back of the tray, you may need to use a small flat screwdriver to push the latch forward with one hand while pulling out the cable with the other.

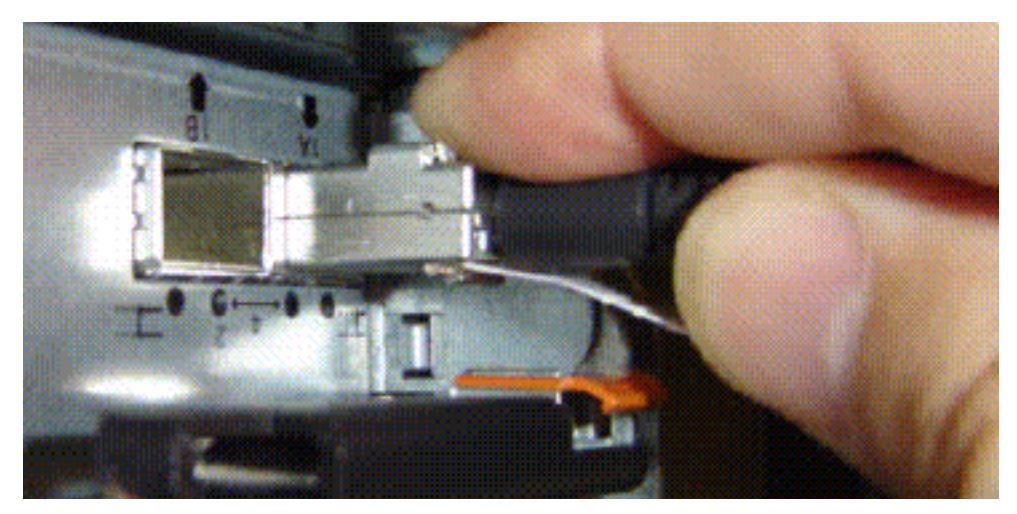
FIGURE A-2 shows a cable being removed from an expansion port (1A) on a controller tray.

**FIGURE A-2** Removing a cable from an expansion tray.

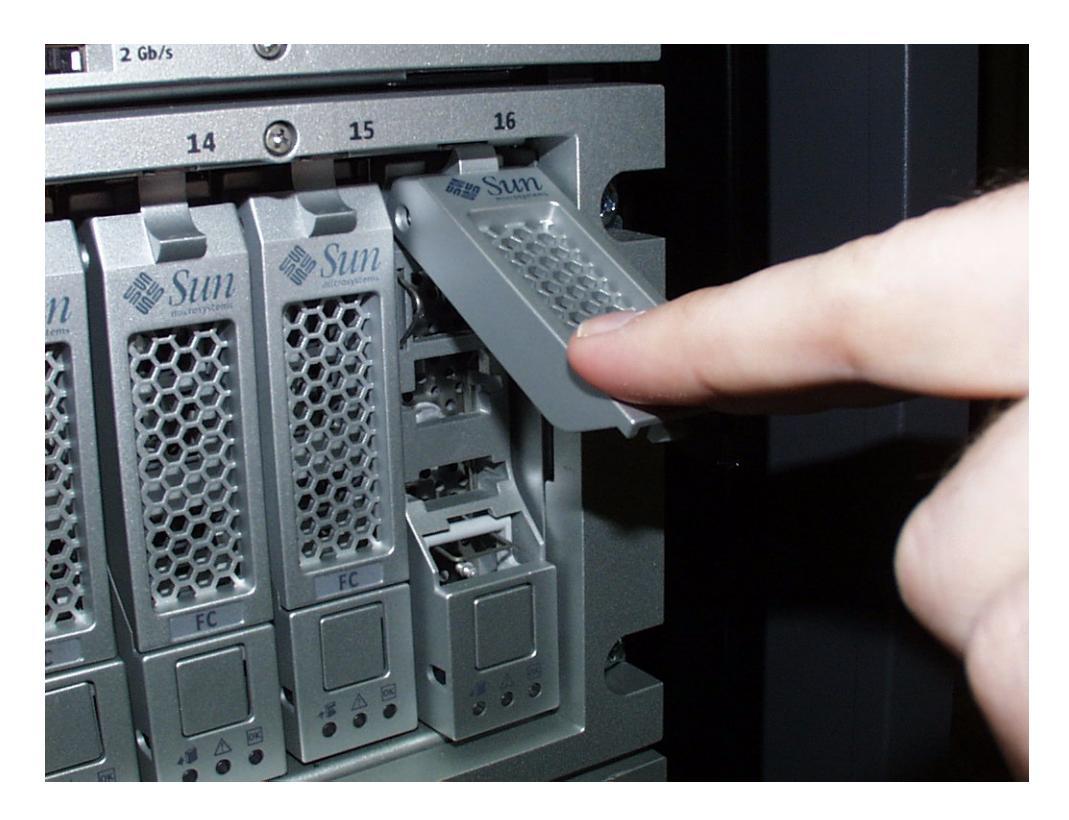
FIGURE B-1 shows a drive being inserted into the chassis the correct way.

FIGURE B-1 Inserting a Disk Drive.

- 1. Push the disk drive into the chassis by slowly pushing against the drive housing until the drive handle engages with the chassis.
- 2. When the handle starts to move itself downwards, push the disk drive handle down. This will crank the disk drive the rest of the way into the chassis.

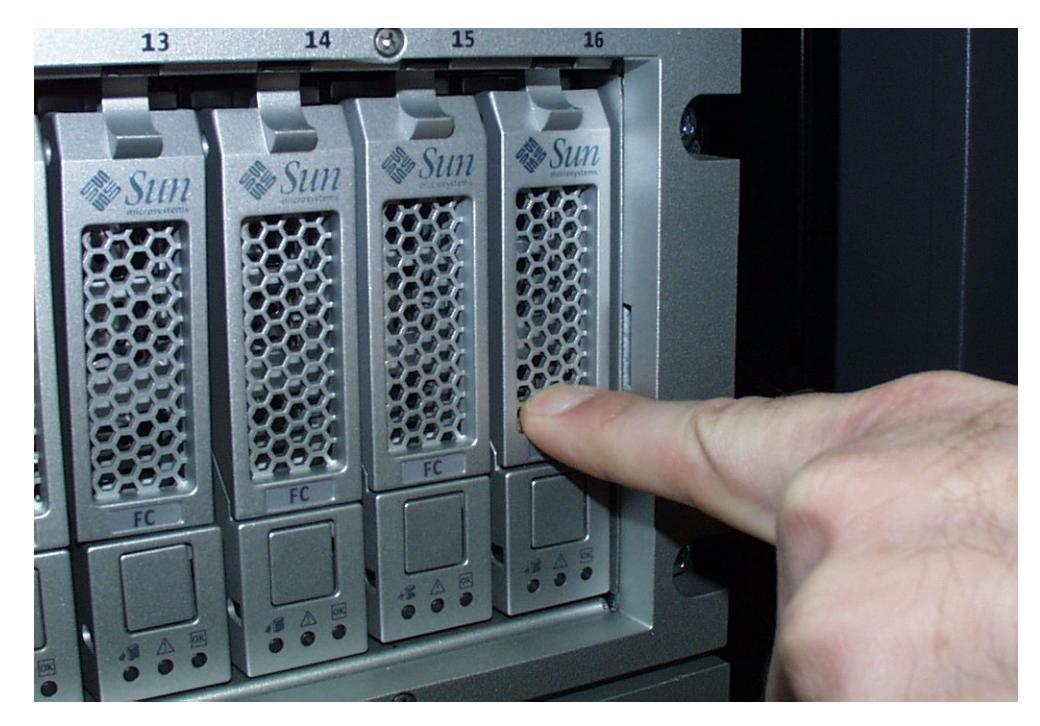
When the drive is completely installed, the drive and handle will be flush with the others, as shown in FIGURE B-2.

FIGURE B-2 Successfully Inserting the Disk Drive

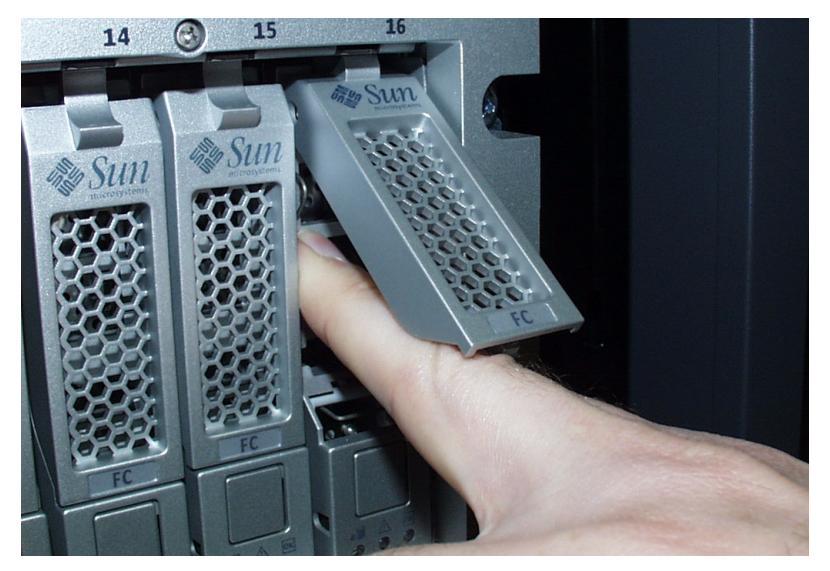
FIGURE B-3 shows the wrong way to insert the drive.

FIGURE B-3 Incorrect Method of Inserting a Hard Drive

**Caution** – Do not insert a disk drive into a tray by pushing on its housing until it is all the way in. This can cause the handle to be stuck in the "up" position so it is unable to close.
